# Report on Salvage Operations Submarine S-51

REPORT ON SALVAGE OPERATIONS  
SUBMARINE S-51

EDWARD ELLSBERG  
LIEUTENANT COMMANDER, CONSTRUCTION CORPS  
UNITED STATES NAVY  
SALVAGE OFFICER

UNITED STATES  
GOVERNMENT PRINTING OFFICE  
WASHINGTON  
1927

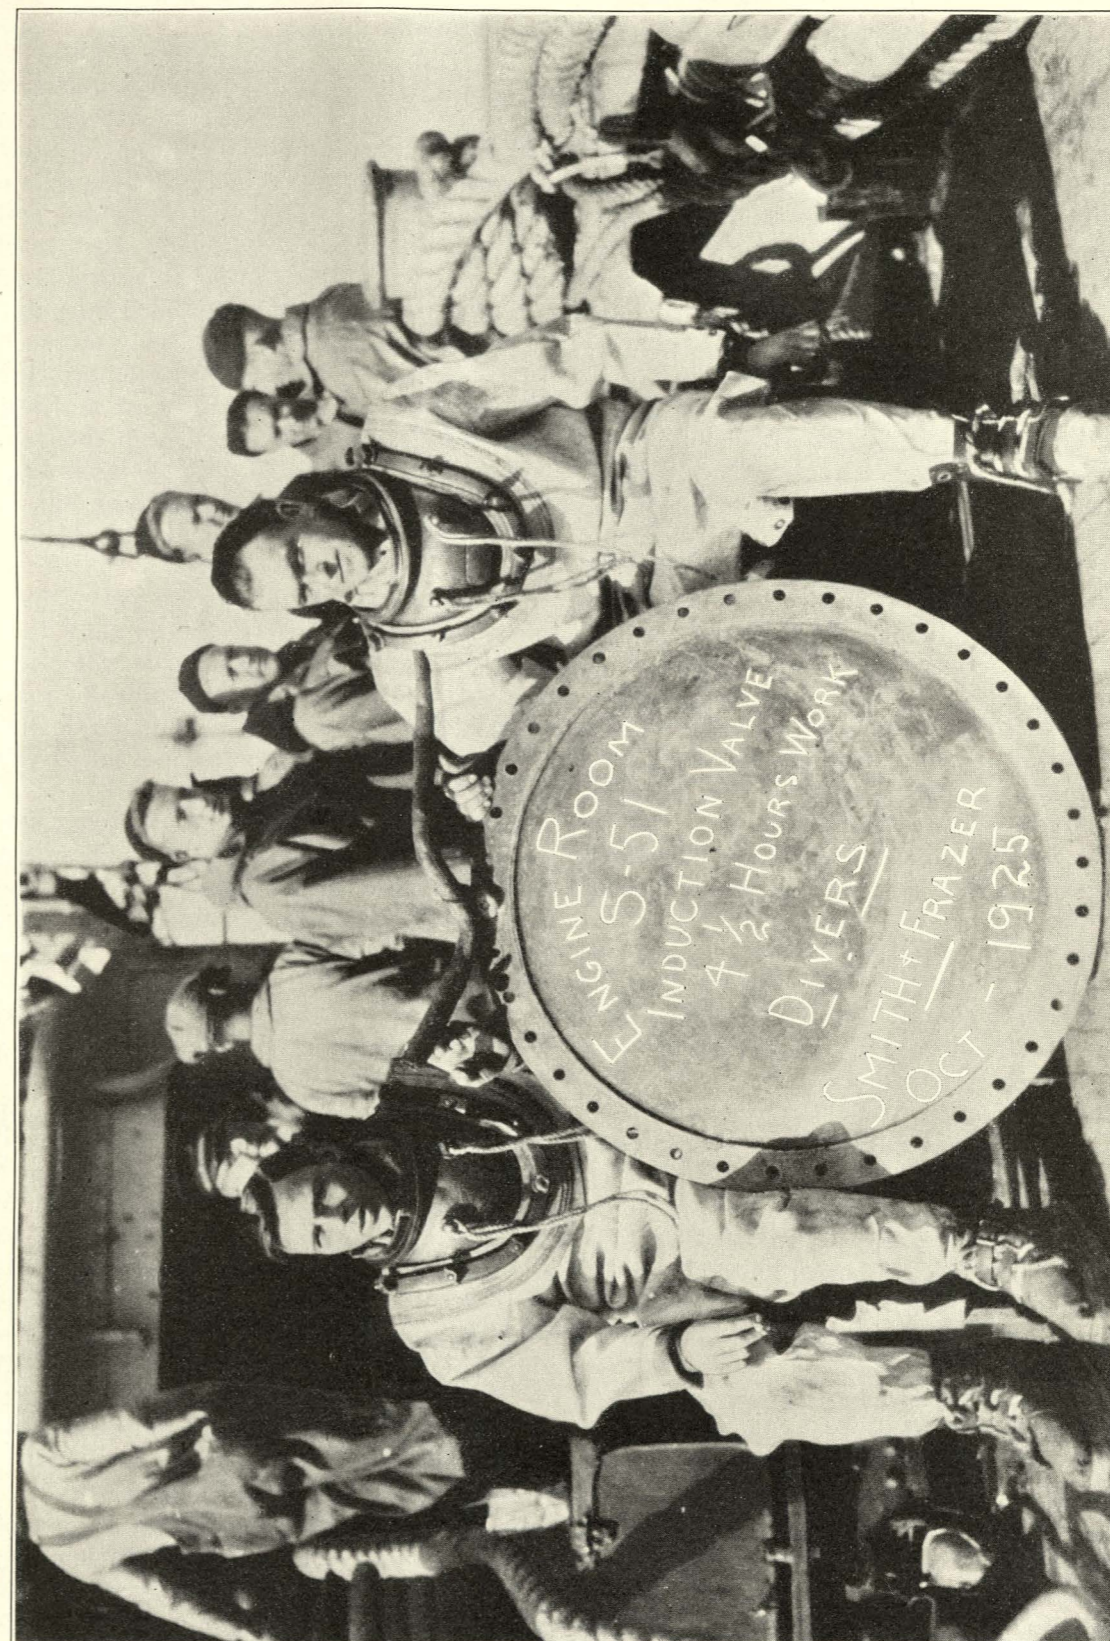
Several days were spent in attempting to clear away the obstruction in the engine air induction valve, but without result. As the valve had to be closed, it became necessary to remove the decking over the valve in the superstructure; tear up the steel deck beams over the valve, using a 6-inch manila line to the *Falcon's* winch for the purpose; unbolt forty ¾-inch nuts which held down the valve bonnet; break the joint and lift off the 300-pound bonnet. All of this work, done by Frazer and Smith, was finished on November 2, when we found a piece of 1-inch steel pipe, 3 feet long and much corroded, jammed under the valve disk. This pipe, evidently left in the vent main during building, had been washed into the valve by the rush of water when the *S-51* sank. (See fig. 5.)

FIG. 5.—MAIN INDUCTION VALVE BONNET. (NOTE 1-INCH STEEL PIPE WHICH WAS JAMMED UNDER VALVE DISK)

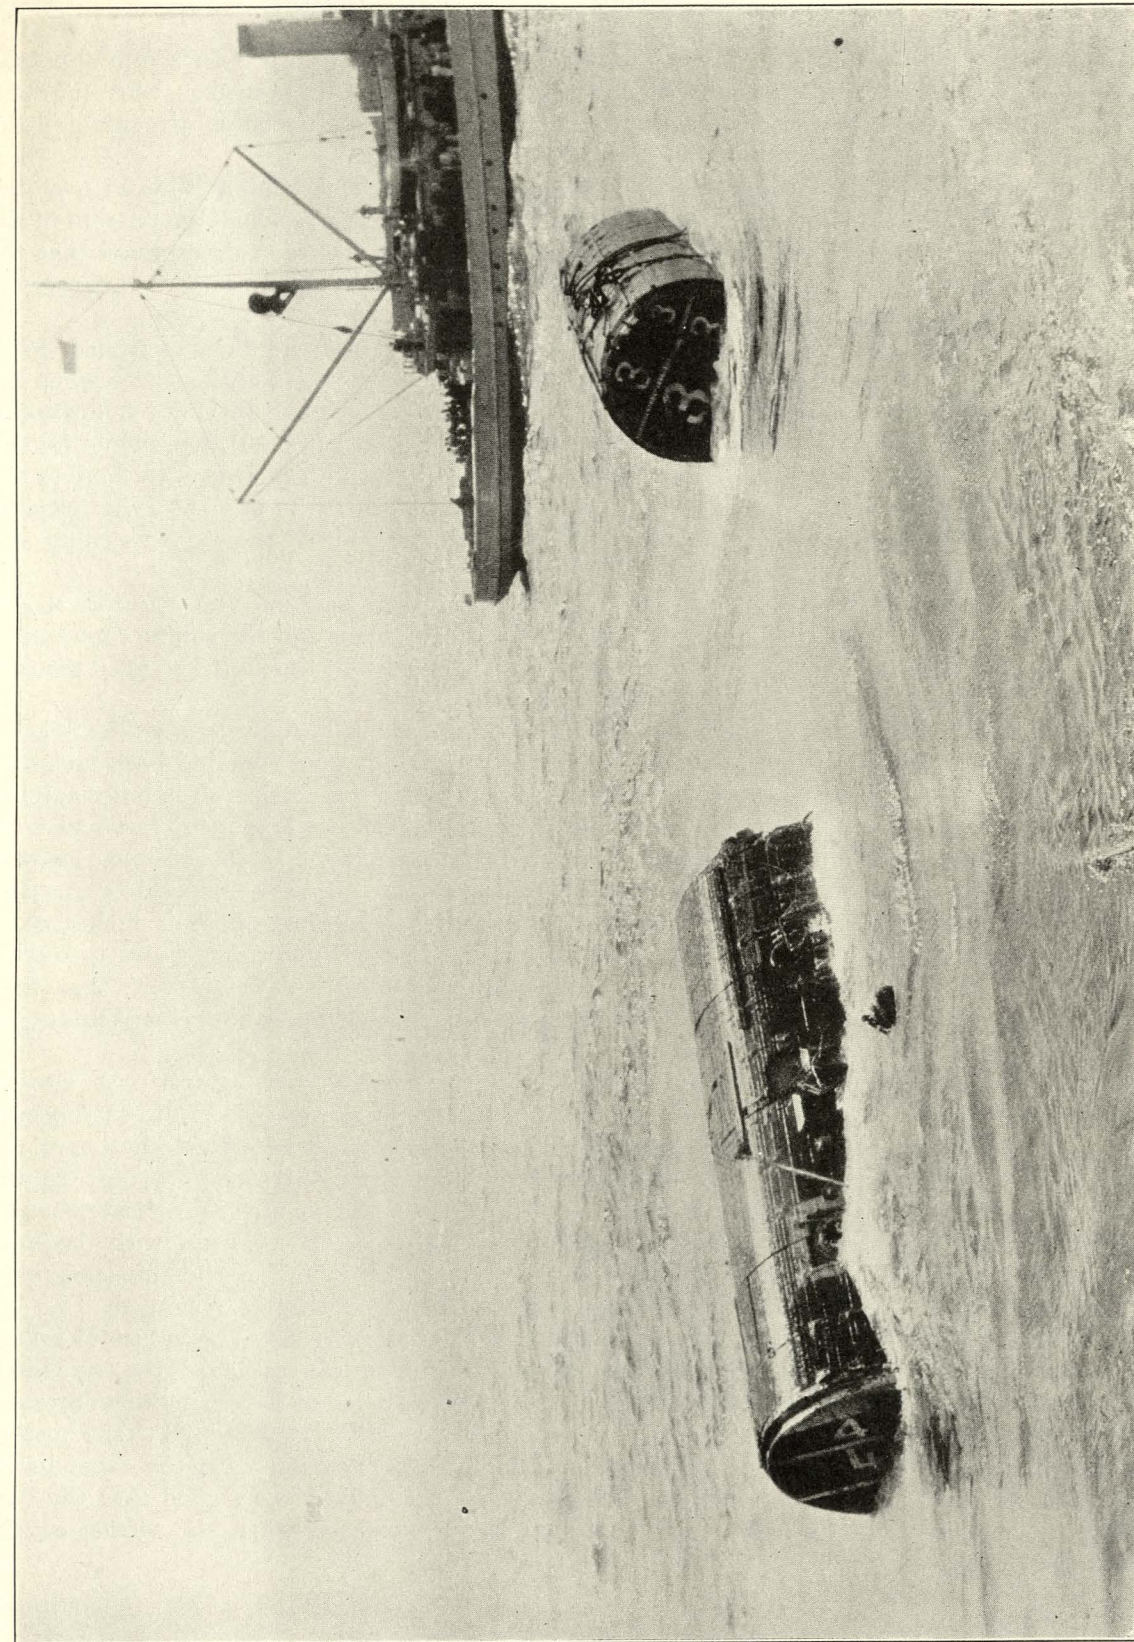
Fig. 15.—STERN PONTOONS WHICH BROKE FREE FROM SUBMARINE, JUNE 22, 1926

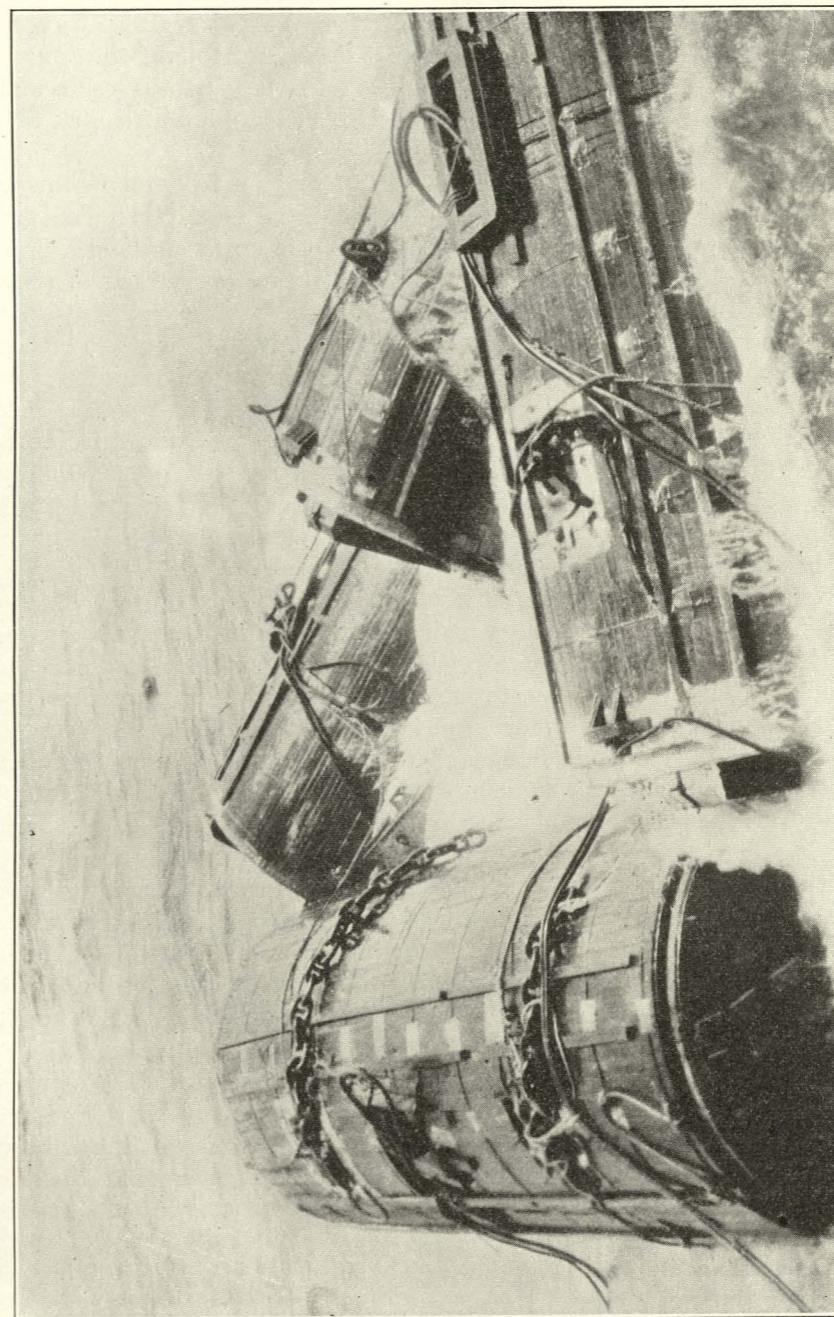
FIG. 16.—BOW PONTOONS DRIVEN OUT OF ALIGNMENT BY THE SEA, JUNE 22, 1926

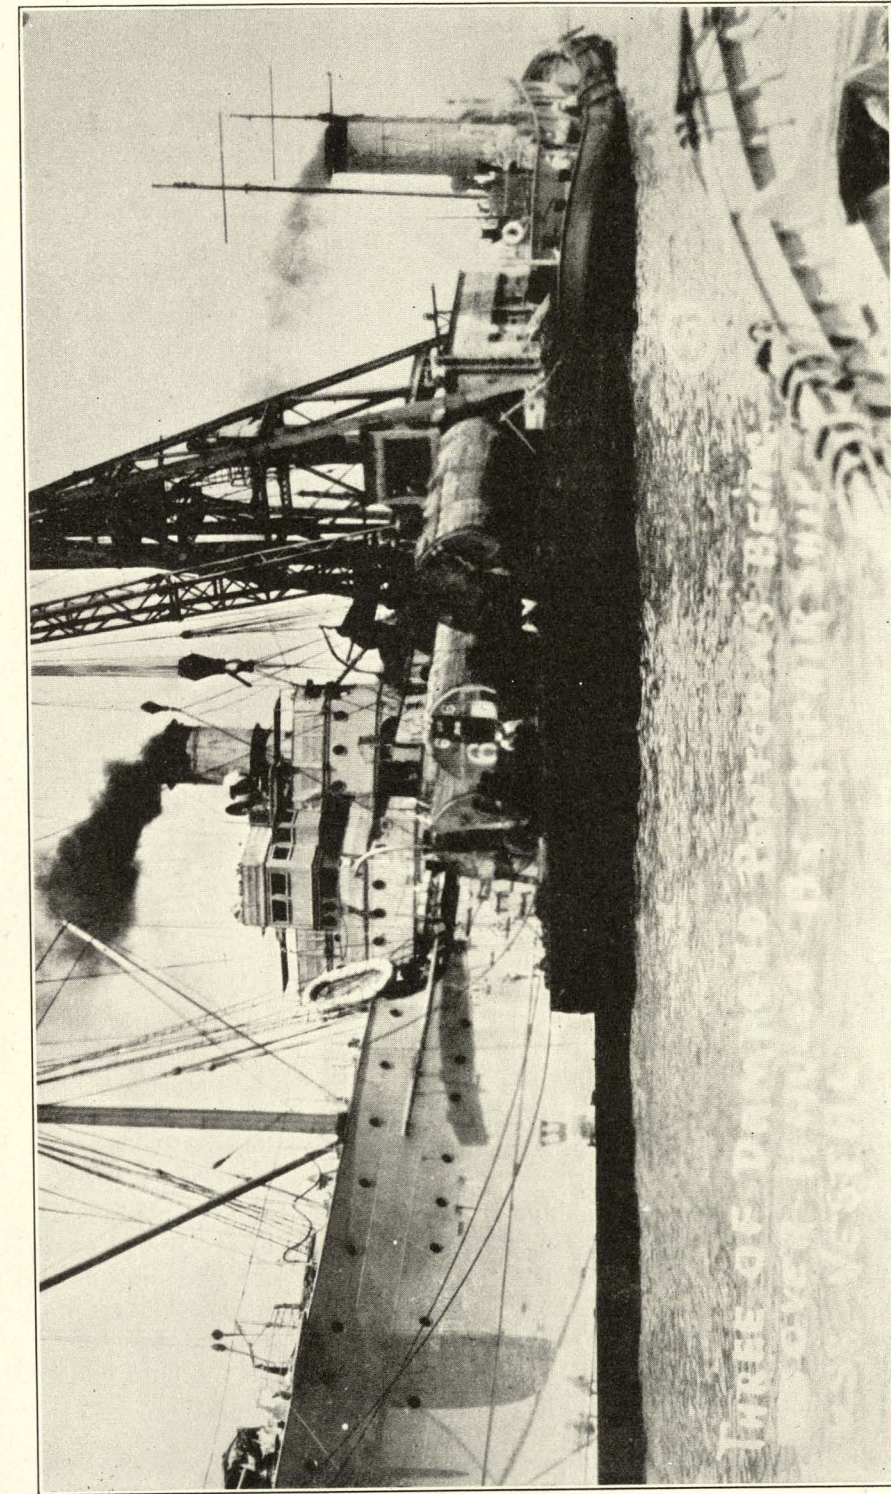
FIG. 19.—DAMAGED PONTONS ABOARD DERRICK "UNITED STATES" AT POINT JUDITH

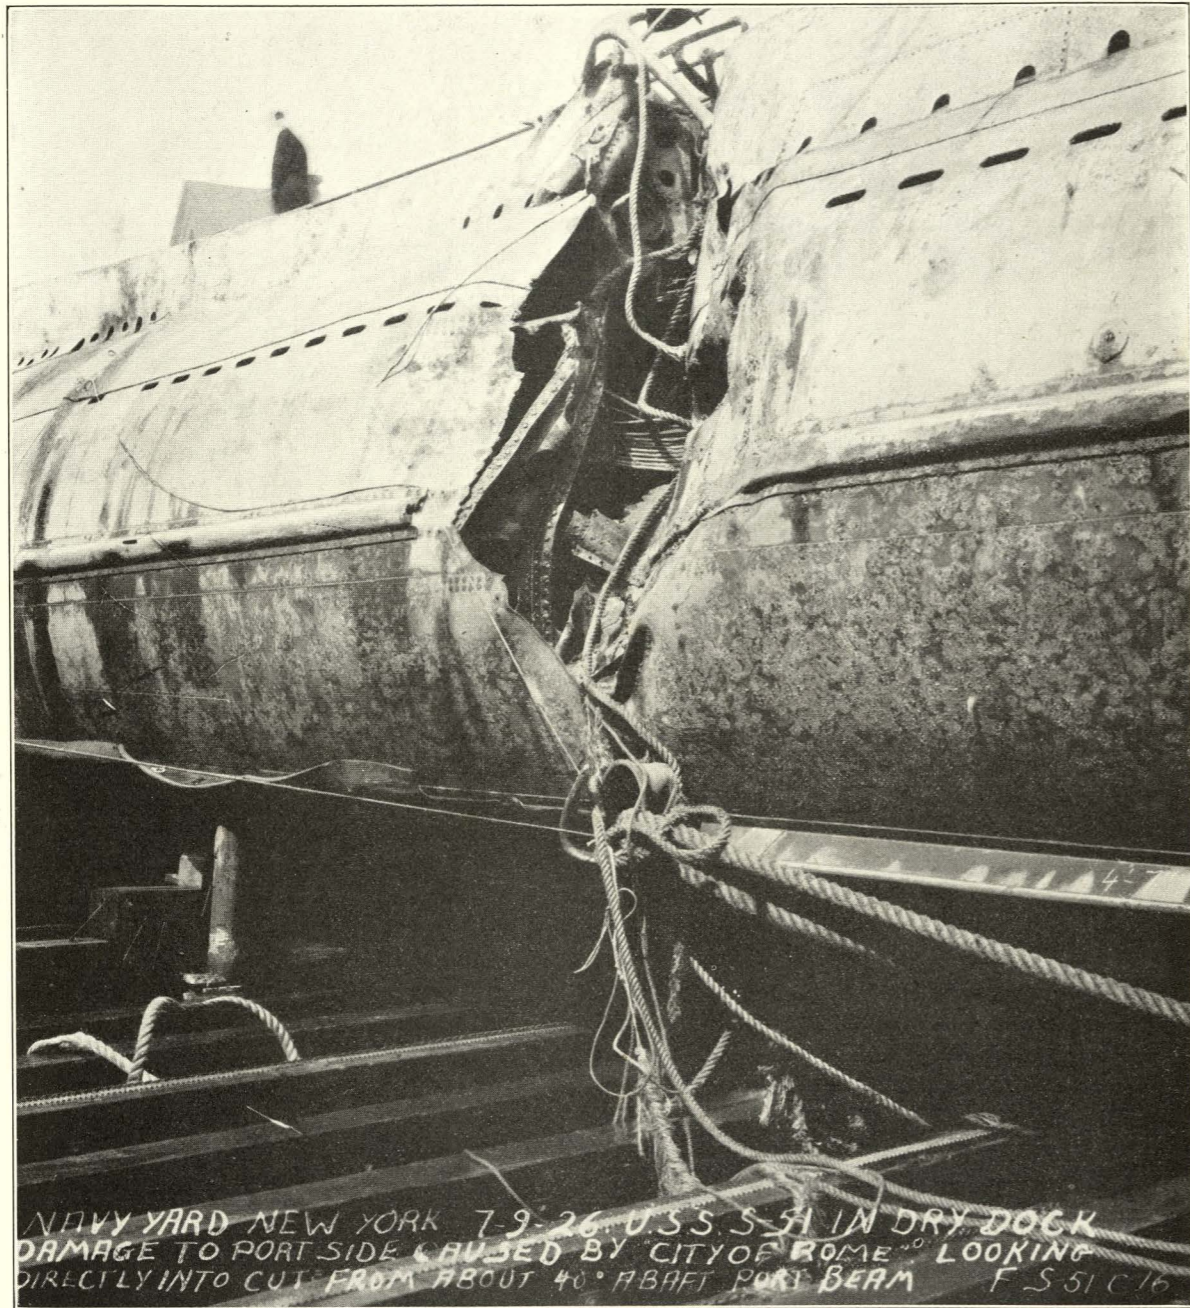
NAVY YARD NEW YORK 7-9-26 U.S.S. S-51 IN DRY DOCK  
 DAMAGE TO PORT SIDE CAUSED BY CITY OF ROME LOOKING  
 DIRECTLY INTO CUT FROM ABOUT 40° AHEAD PORT BEAM FS 51C 16

FIG. 39.—DETAIL VIEW OF GASH RESULTING FROM COLLISION WITH "CITY OF ROME"

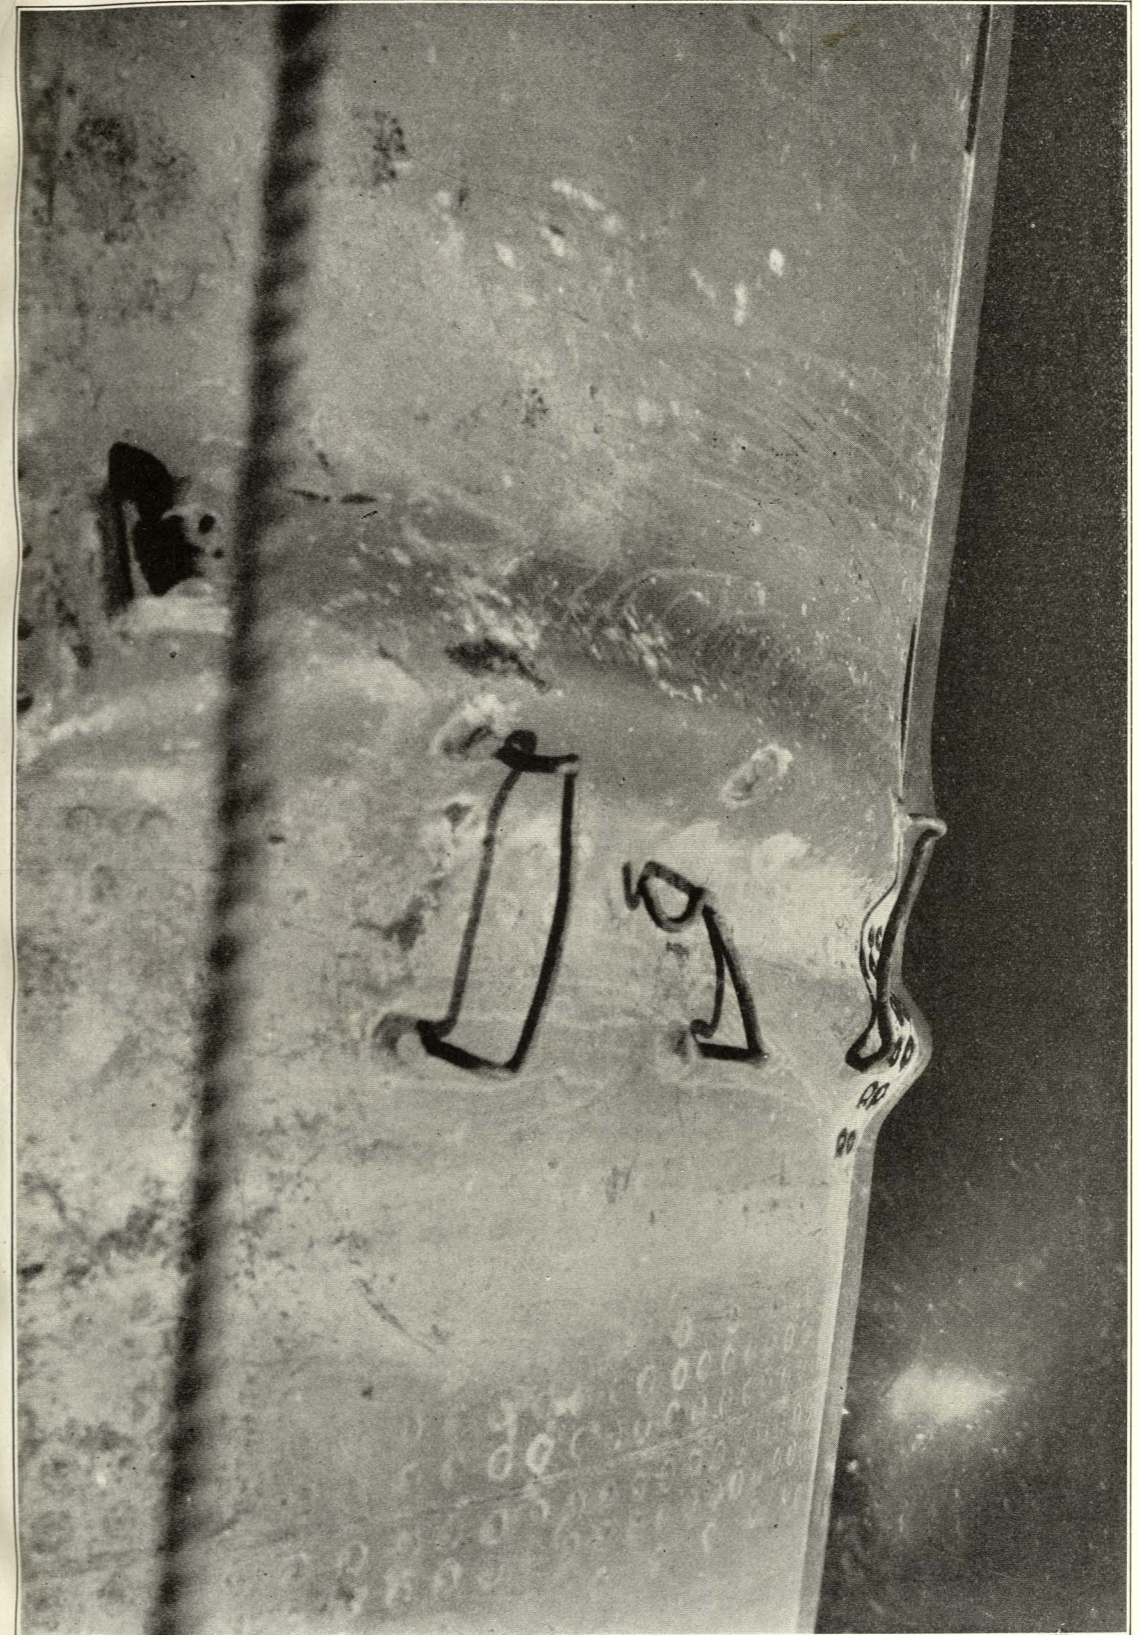
*Torpedo room.*—On sinking, the *S-51* hit the hard bottom, bow first, with considerable way still on. As a result, the hull had buckled at bulkhead 43, where the structure changed from single to double hull, making a point of discontinuity in strength. At this bulkhead there were two deep circumferential wrinkles showing on the shell plating, these standing out from the shell about 4 to 6 inches along the upper hull and fading out gradually toward the keel. The after bulkhead of the torpedo room was thus badly damaged in its shell connections. In addition, practically every air and drainage line to the torpedo room was severed at the point of collision, making air-tightness hard to obtain.

FIG. 40.—PORT SIDE VIEW SHOWING WRINKLE CAUSED BY BOW STRIKING BOTTOM AFTER COLLISION WITH "CITY OF ROME"

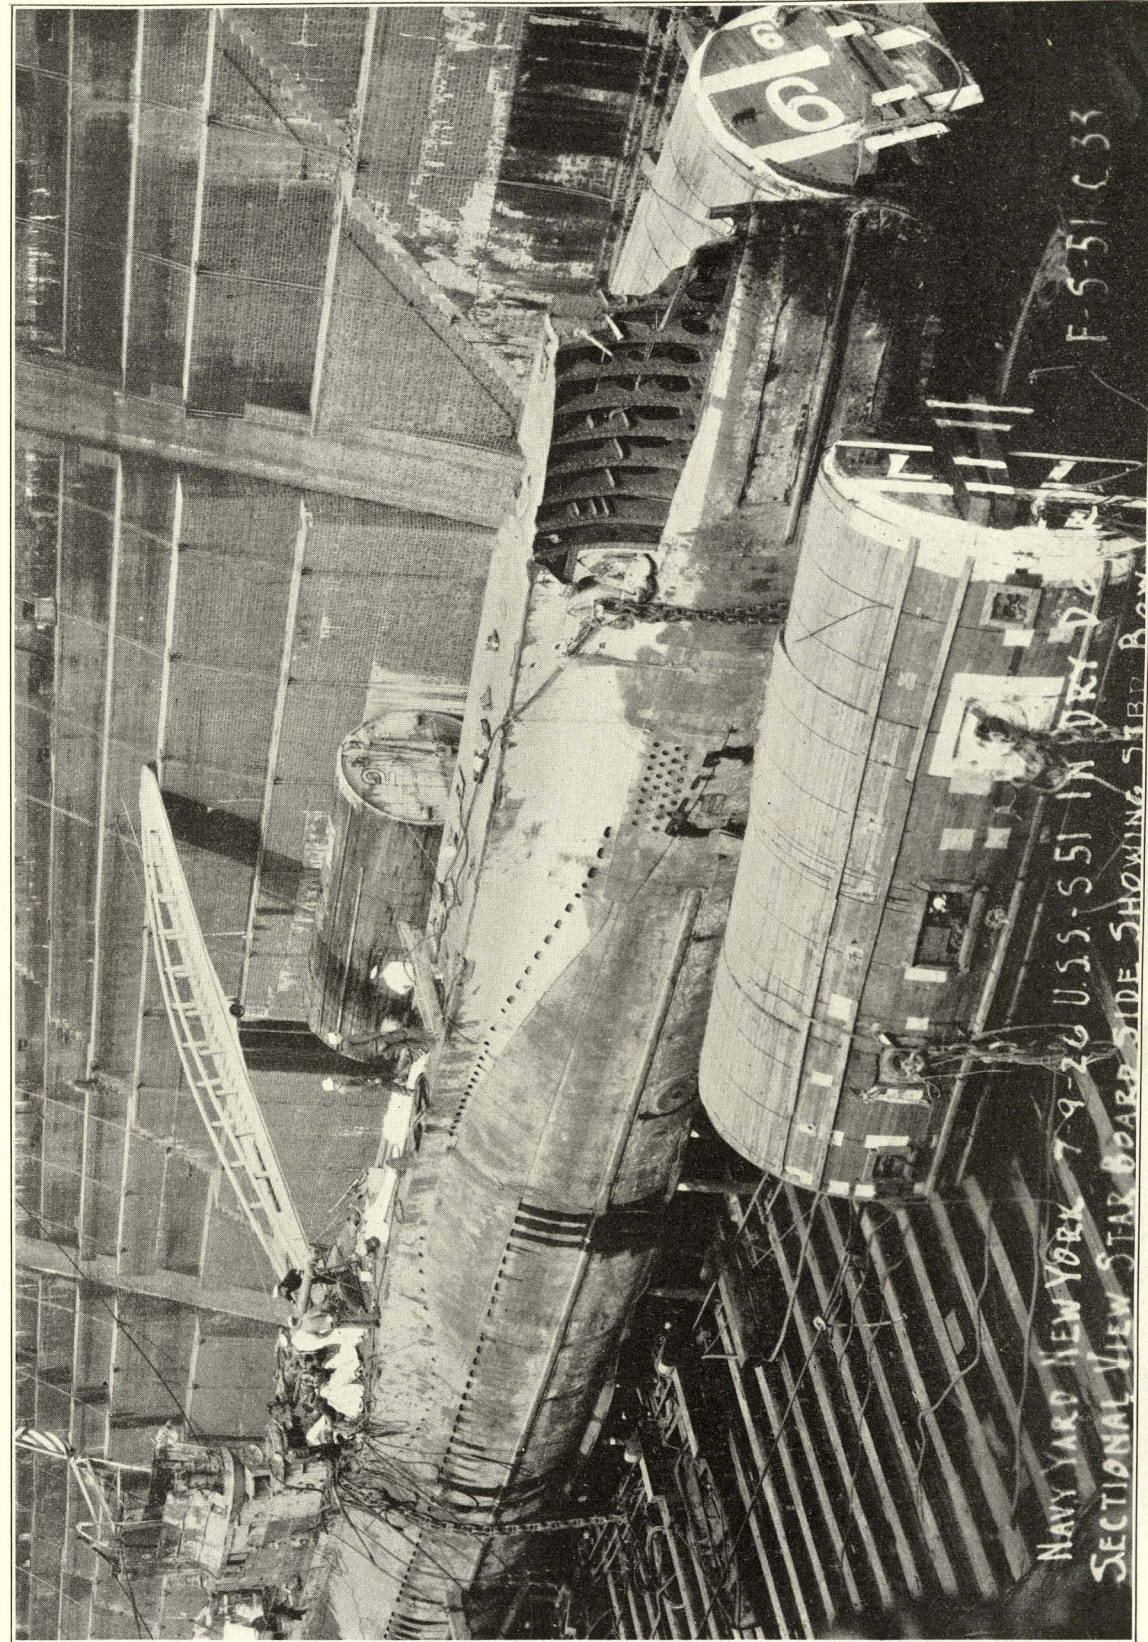
FIG. 41.—VIEW SHOWING DAMAGE TO BOW CAUSED BY GROUNDING ON MAN-OF-WAR ROCK

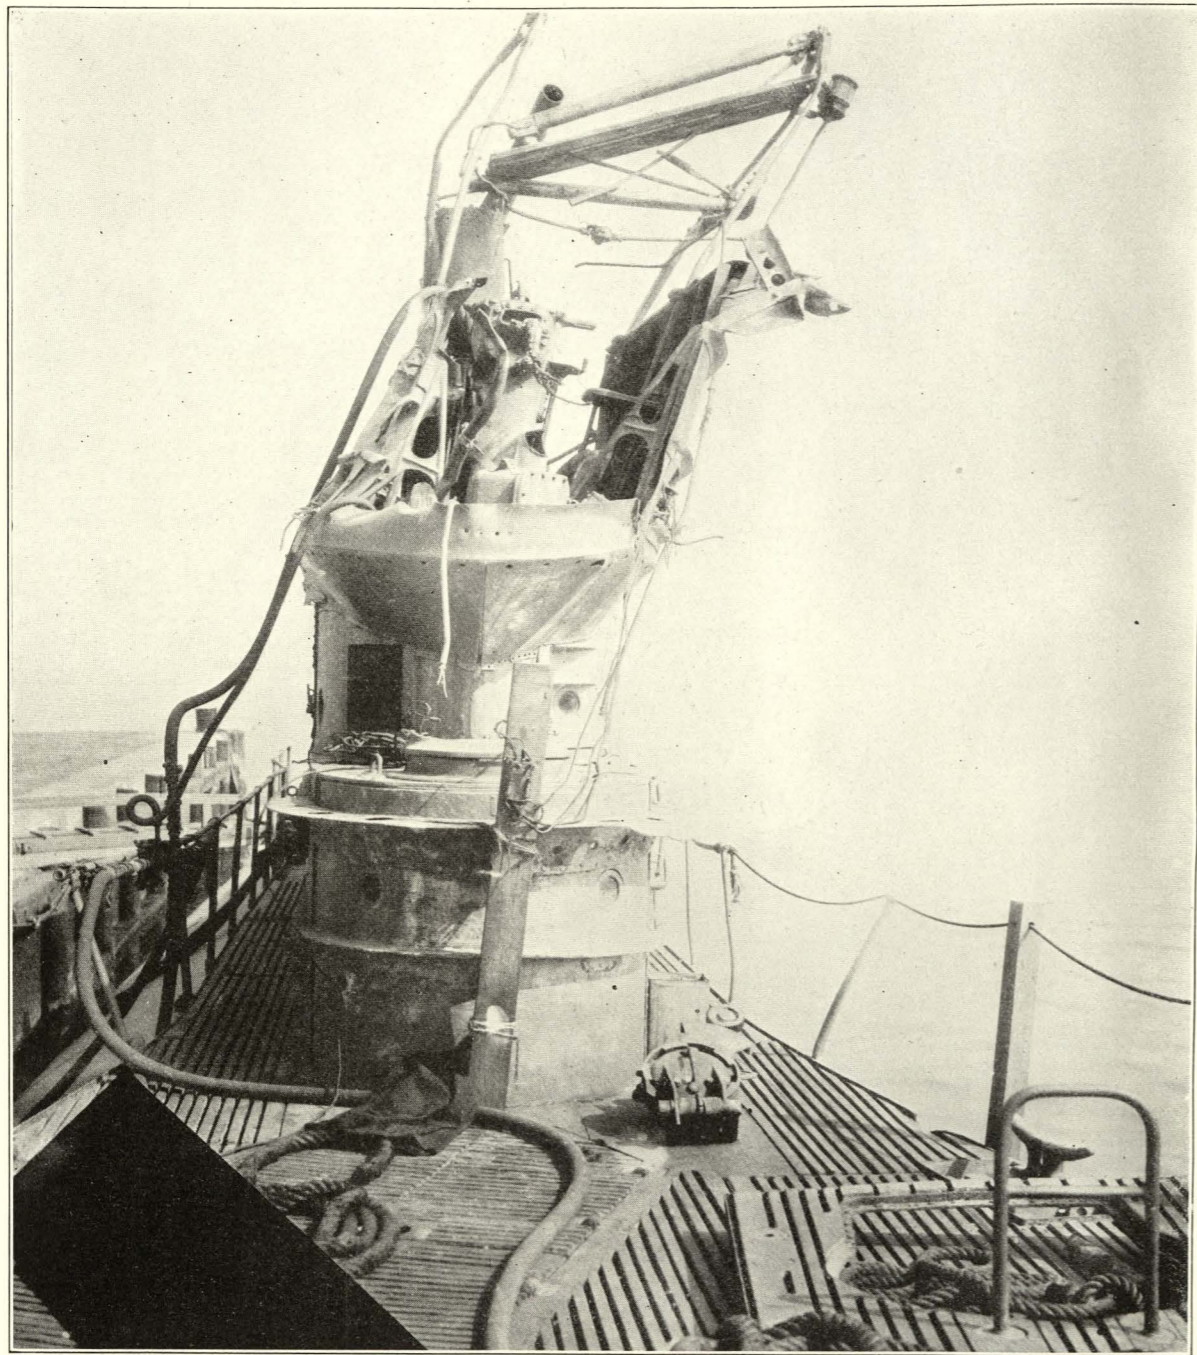
FIG. 43.—VIEW OF BRIDGE BADLY BENT TO PORT FROM LEANING AGAINST STARBOARD NO. 3 PONTON

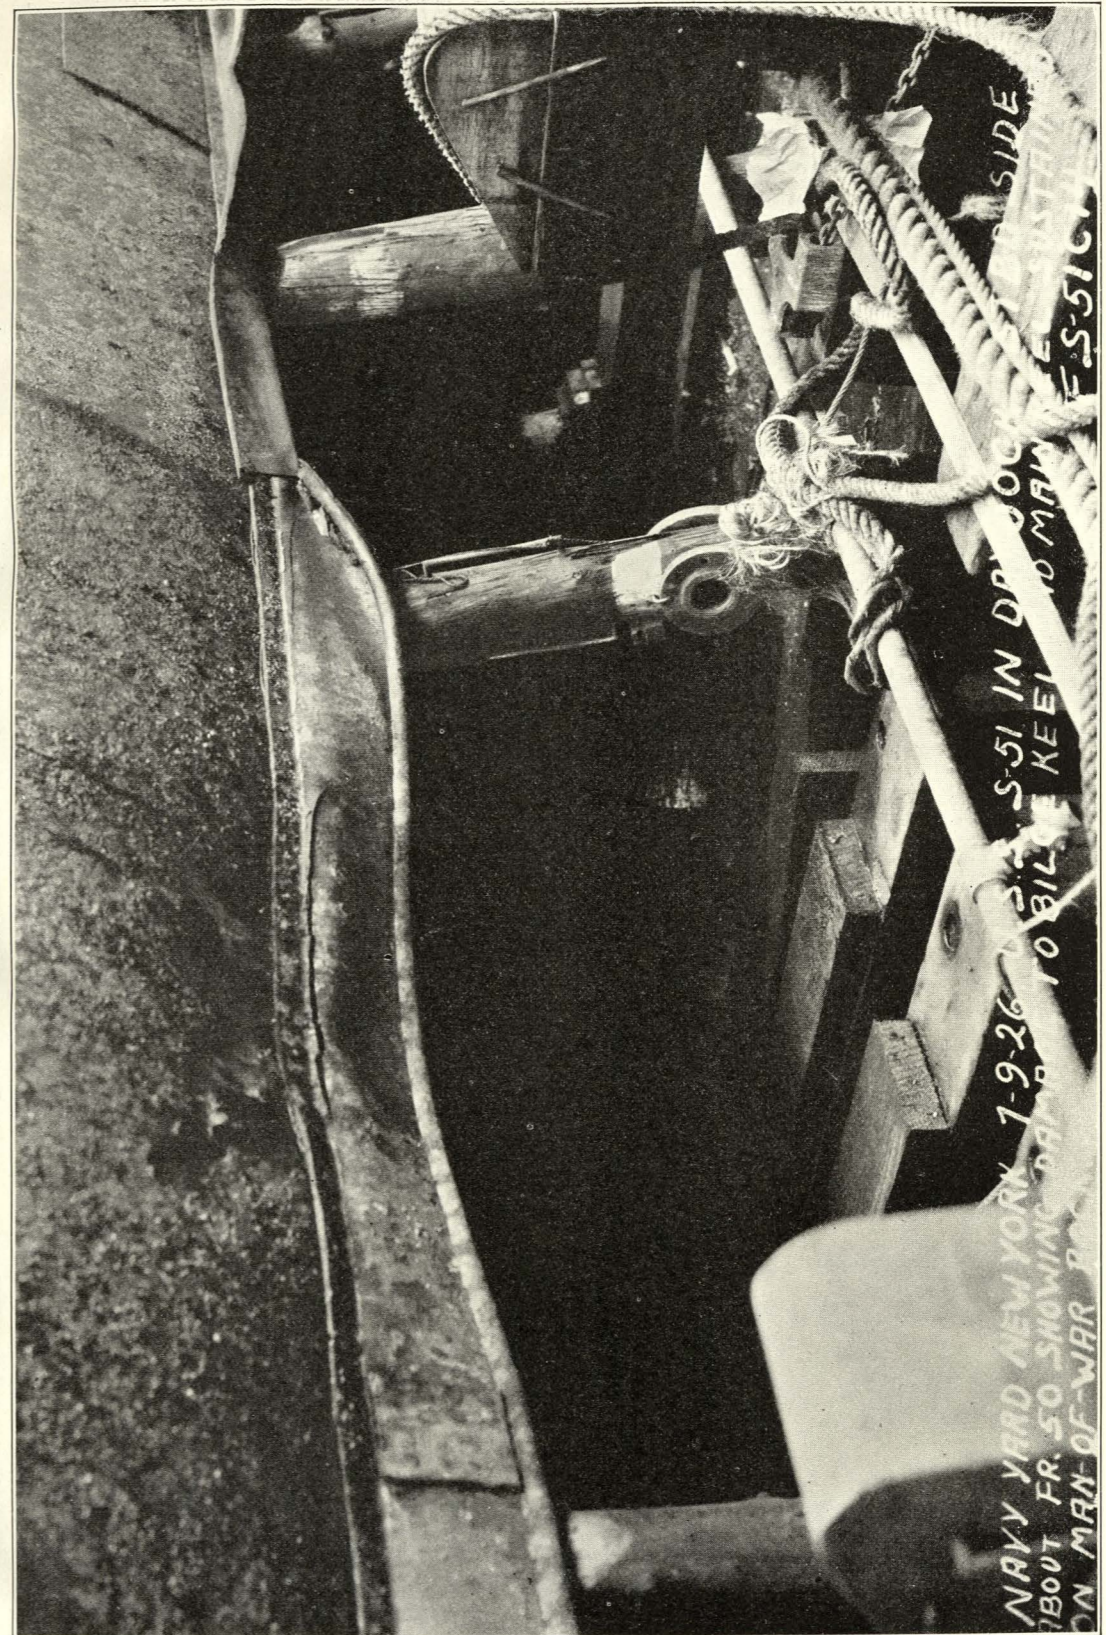
FIG. 44.—DAMAGE TO BILGE KEEL AND MAIN KEEL DUE TO GROUNDING ON MAN-OF-WAR ROCK. (NOTE PIECES OF STONE ON BILGE KEEL)
