# Report on Salvage Operations Submarine S-51

REPORT ON SALVAGE OPERATIONS  
SUBMARINE S-51

EDWARD ELLSBERG  
LIEUTENANT COMMANDER, CONSTRUCTION CORPS  
UNITED STATES NAVY  
SALVAGE OFFICER

UNITED STATES  
GOVERNMENT PRINTING OFFICE  
WASHINGTON  
1927

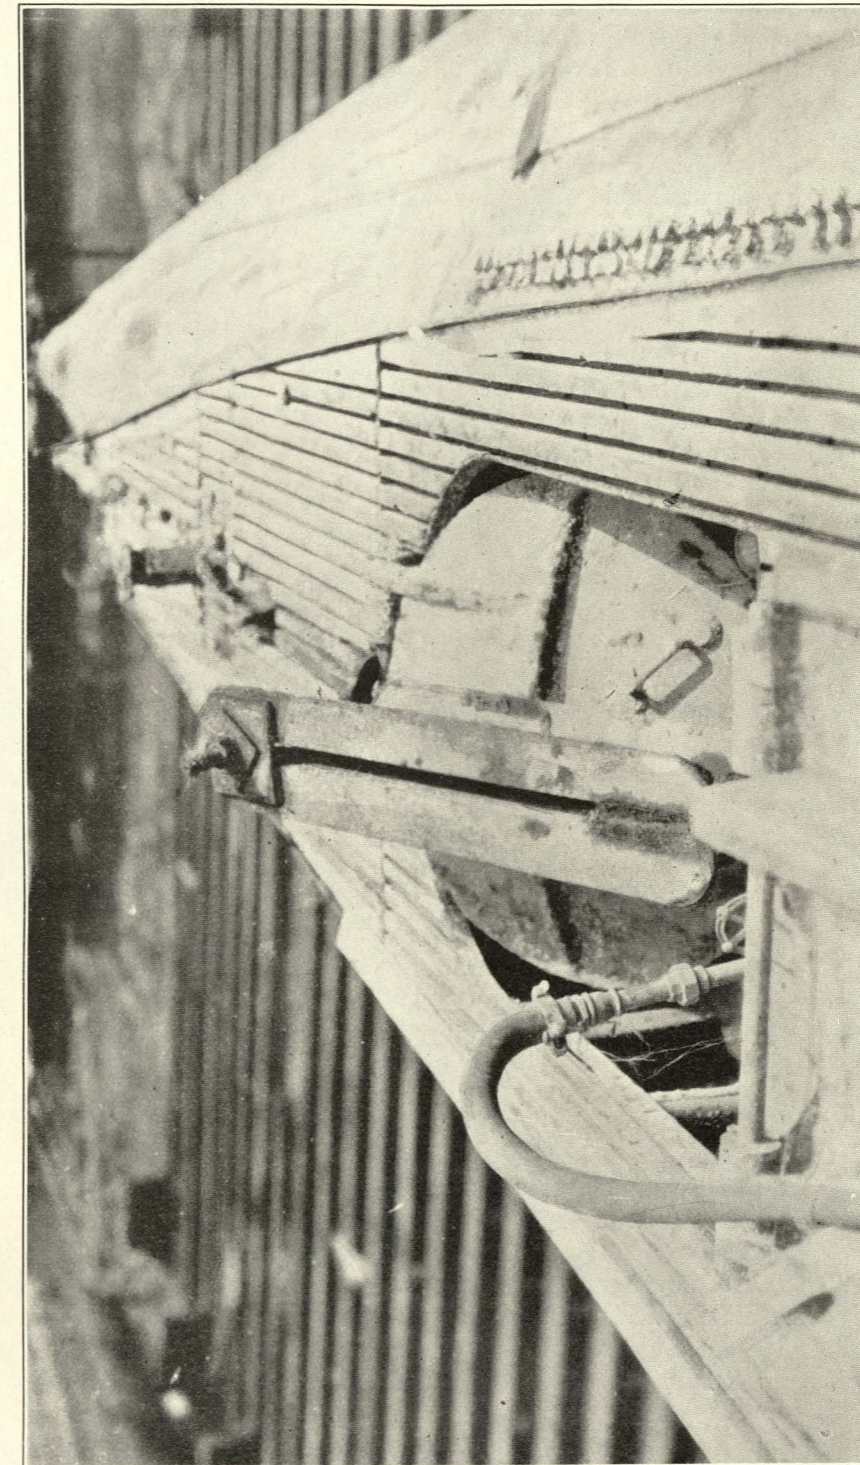
FIG. 6.—CHANNEL STRONG BACK SECURING MOTOR ROOM HATCH

To seal off the motor room, Eiben and Wilson entered from the engine room and closed all necessary valves, including the ventilation valve. Later they closed the motor room door and sledged down the dogs. To discharge the water, the drain valve in the forward bilges (pl. 1) of the motor room was opened, there being a nonreturn valve on the bilge suction. In the engine room a valve bonnet on this drain line was removed so that water could be forced from the motor room to the engine room but not in the reverse direction. To admit air, Kelley and Anderson removed a bolt through the top of the motor room, tapped out the bolt hole, and secured a  $\frac{3}{4}$ -inch connection for a blowing hose. To prevent blowing open the motor room hatch under internal pressure, an external strong back was made and bolted down over the hatch, as shown in Figure 6.

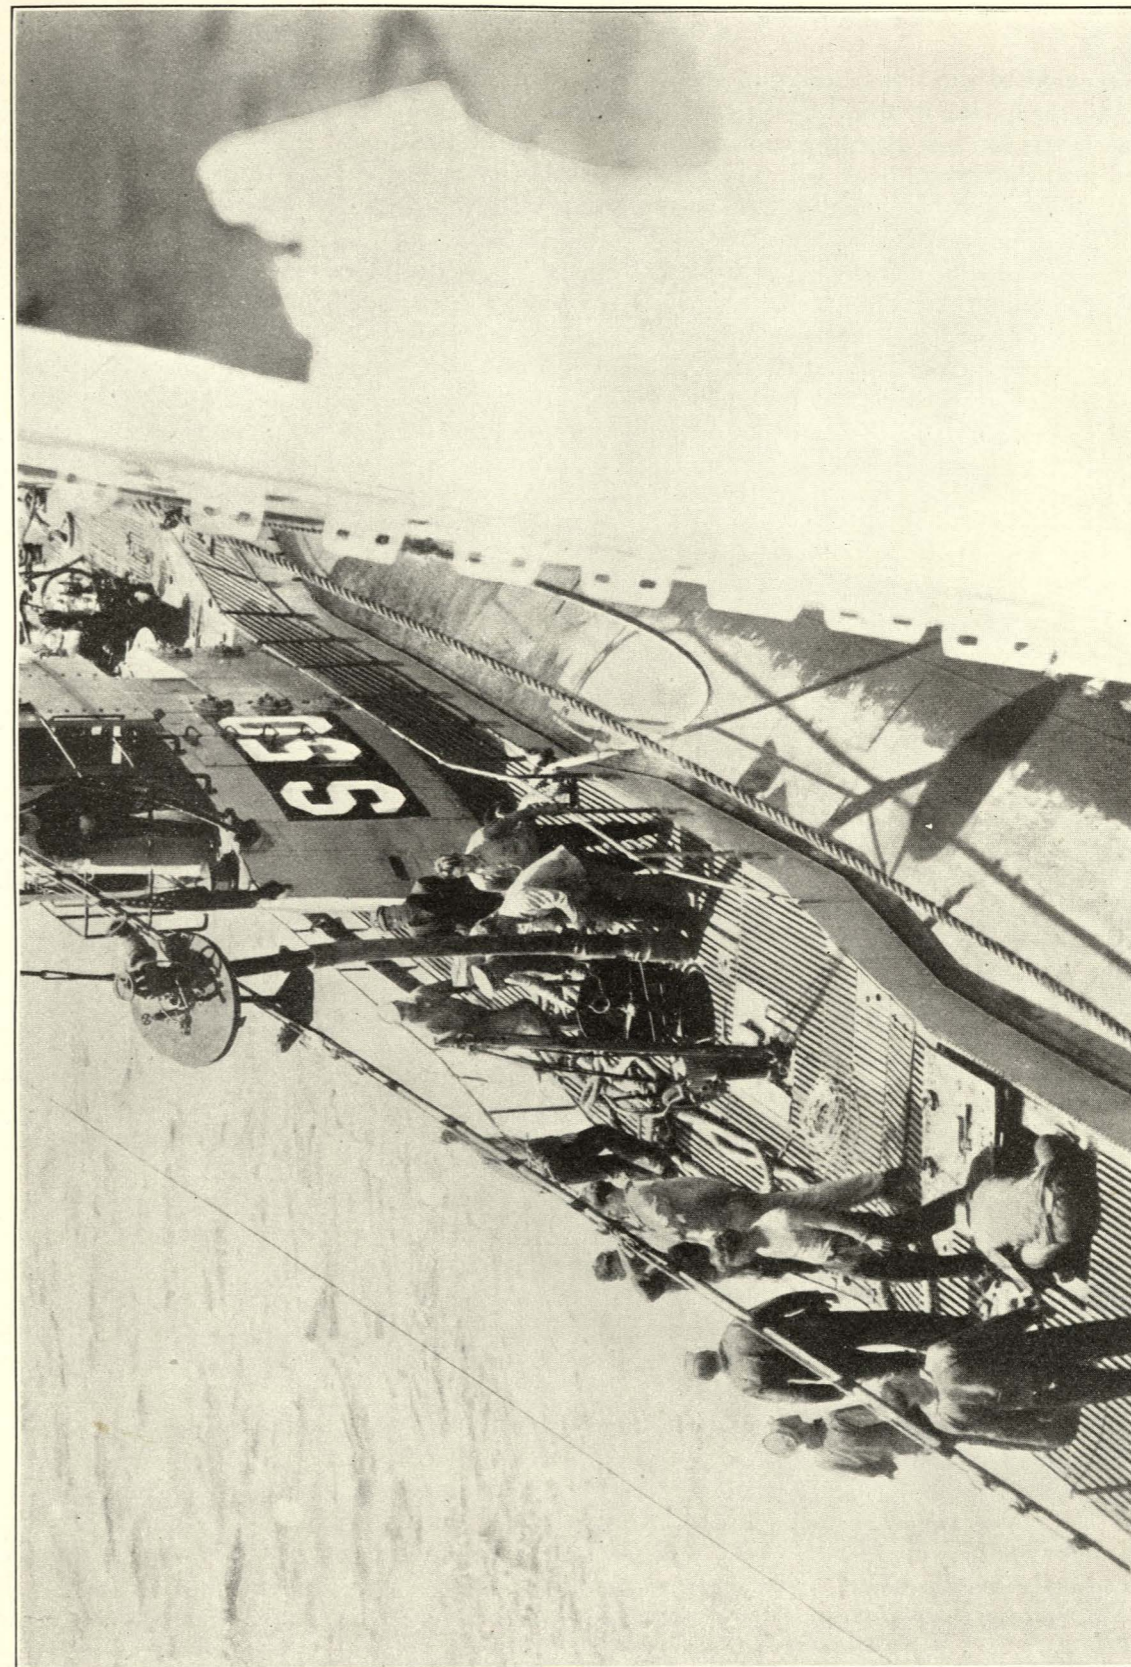
FIG. 7.—ENGINE ROOM SALVAGE HATCH. PRACTICE ON "S-50." (NOTE 4-INCH HOSE)

Handling the salvage hatches presented a new problem. Each hatch was made of steel plate  $1\frac{1}{4}$  inches thick, with a heavy strong back and bolt running through it, and with a long length of 4-inch suction hose attached to the underside about as shown in Figure 7. Each hatch weighed around 700 pounds assembled.

After a second pair of divers had tried to adjust the hatch and failed, the hatch and strong back assembly was sent back up to the *Falcon*, where the rig was redesigned for installation in two parts, the strong back to be installed separately and held in place, centered, by a light auxiliary strong back near the top of the trunk, after which the hatch cover was to be lowered in place. This design was tried on the *S-50*, found satisfactory, and the divers rehearsed in its use. (See fig. 7.)

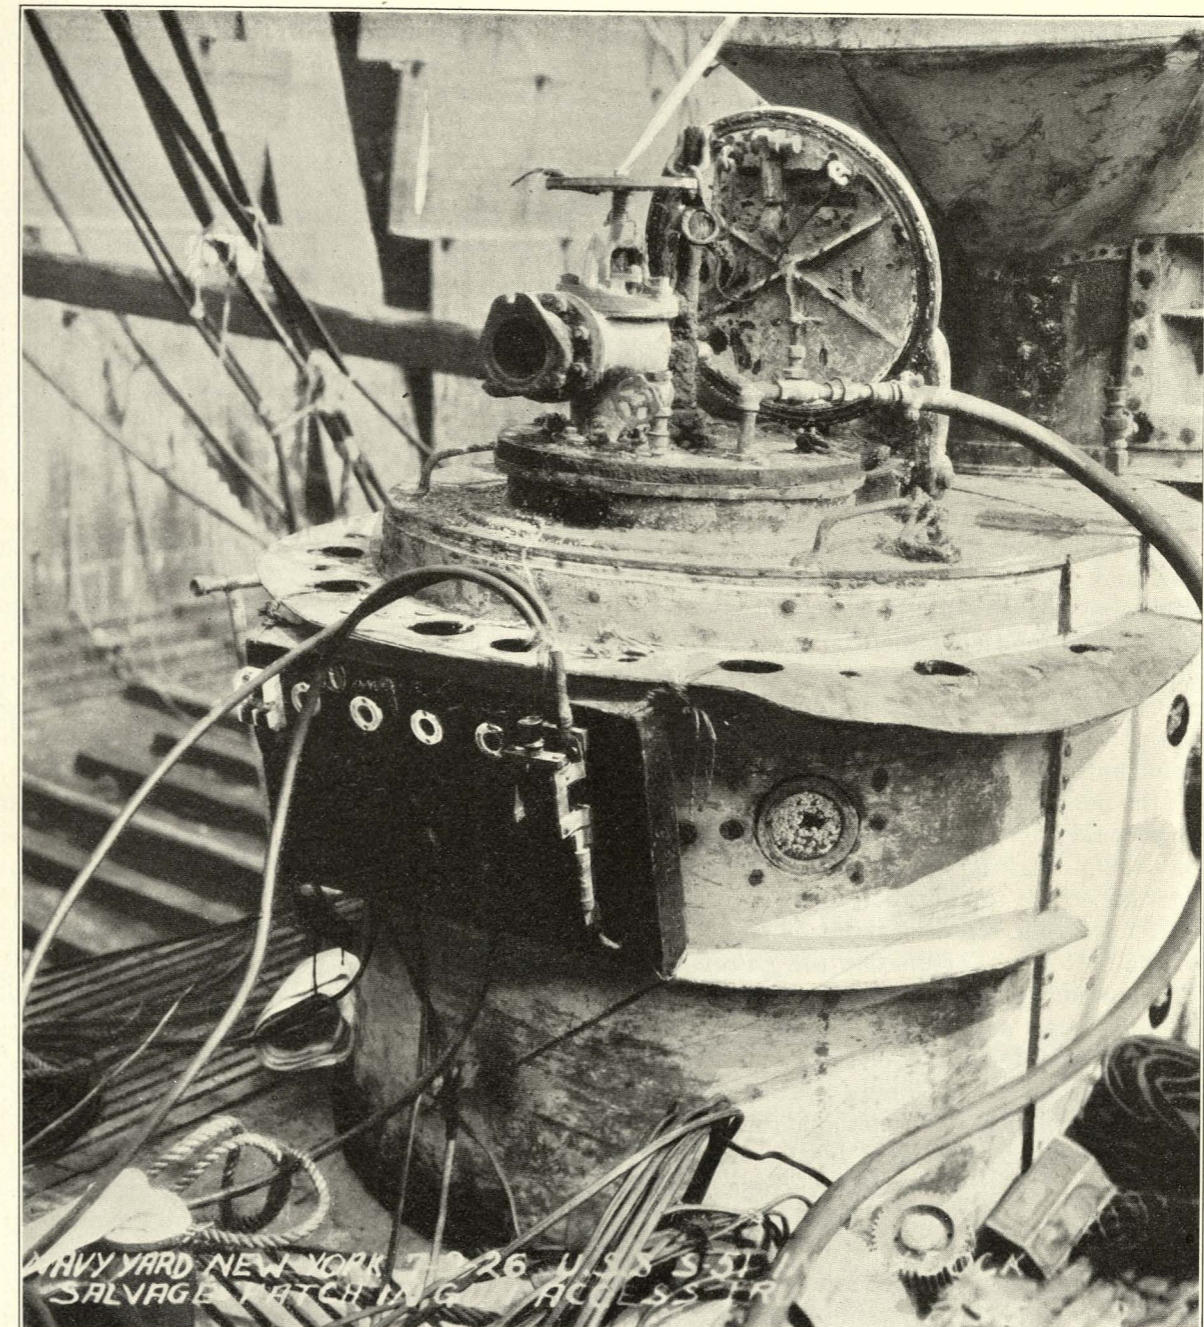
FIG. 8.—GUN ACCESS SALVAGE HATCH IN POSITION. (NOTE AIR CONNECTIONS)

a line secured to the side of the gun access trunk. As the hatch neared the submarine it was dragged over by the divers, who entered the suction hose into the trunk and fed it down until the hatch was landed when the surface line was let go by the divers. The chain fall was then hooked into the strong back bolt and the hatch was thereafter handled from the chain fall by divers. Considerable difficulty was encountered with this hatch in getting it adjusted, on account of the slope of the submarine boat, but this hatch was also successfully installed by Frazer and Smith in one dive. However, it appears that the exertion of handling this heavy weight while plumbing the hatch was such that Frazer strained his heart and it was discovered that further diving by Frazer was out of the question. (Gun access hatch, fig. 8.)

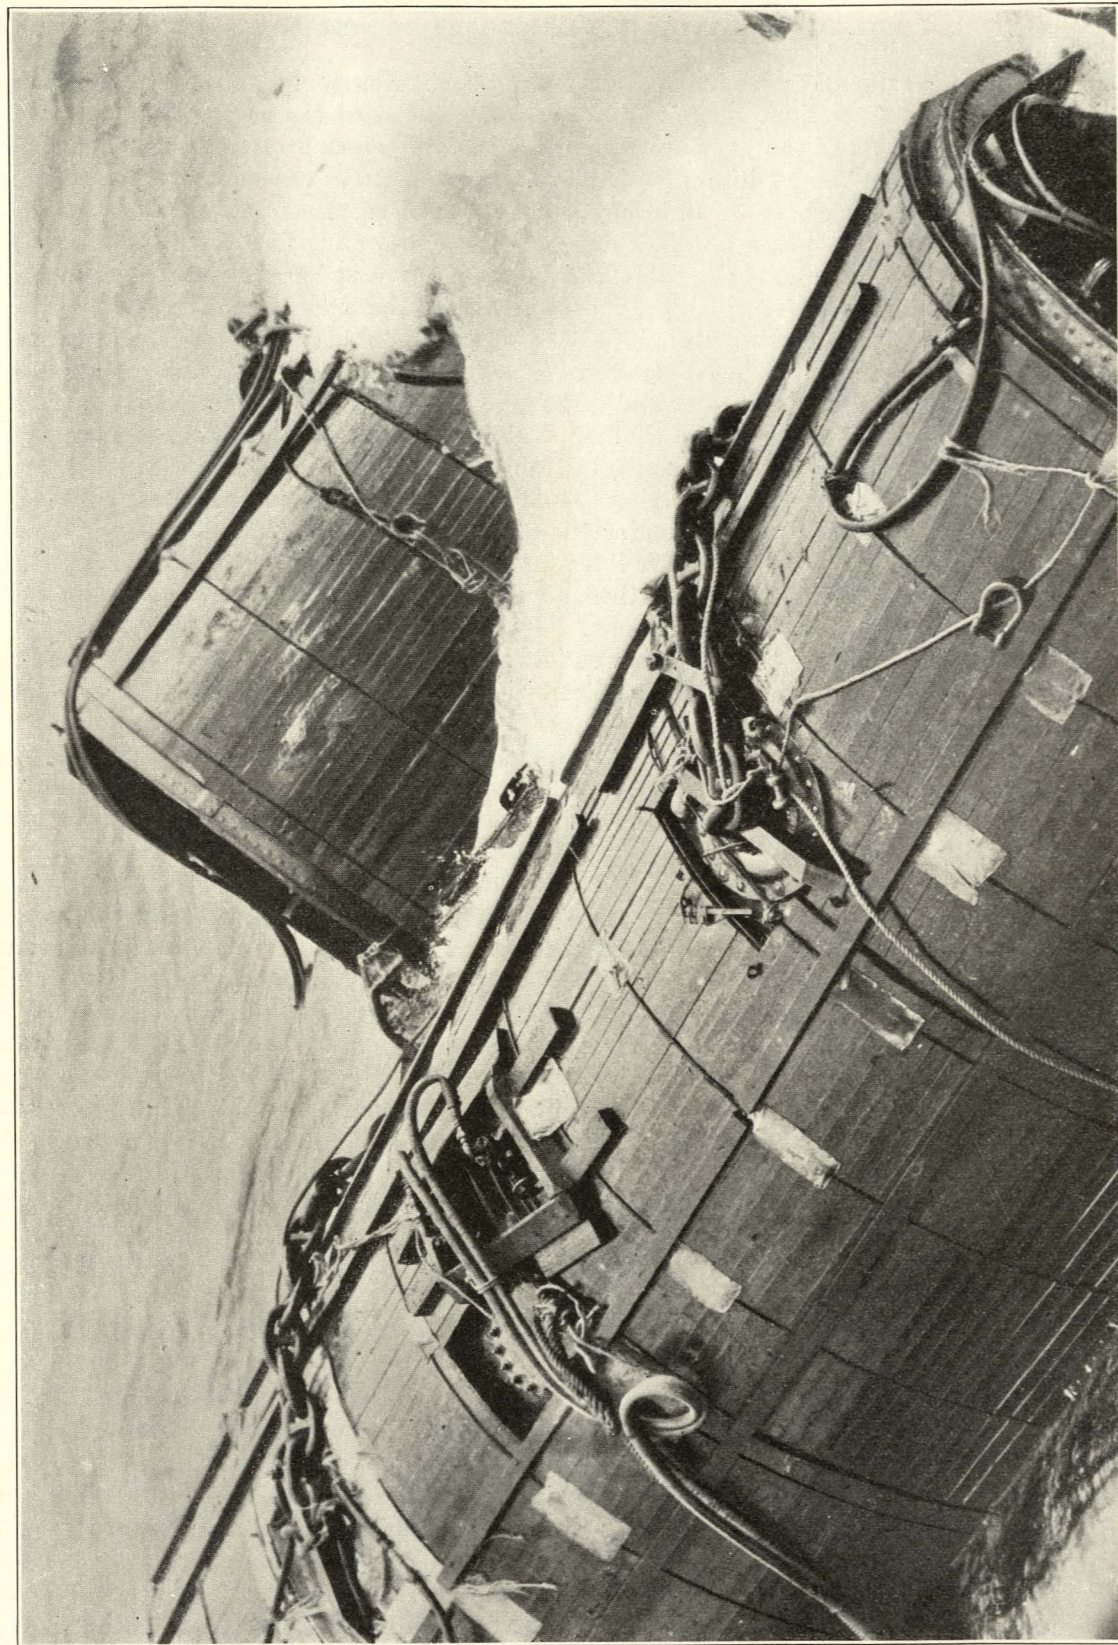
FIG. 9.—BOW PONTOONS. (NOTE NICKEL-STEEL TOGGLE BAR THROUGH LINK, LOCKED IN POSITION BY 1/2-INCH BOLT EACH SIDE)

The torch was then used for the first time in actual work on the job. The chains were hauled through the pontoon hawse pipes for a predetermined amount after which a stud in the link just above the hawse pipe was burned out of each chain and a nickel steel toggle bar 40 inches long and  $3\frac{3}{4}$  by  $3\frac{3}{4}$  inches in section was slipped through the chain and locked in position by a long half-inch bolt on each side of the chain link. (See fig. 9.) When this had been completed, the lowering lines were cast loose and the hauling wires were burned free of the chain and taken up.

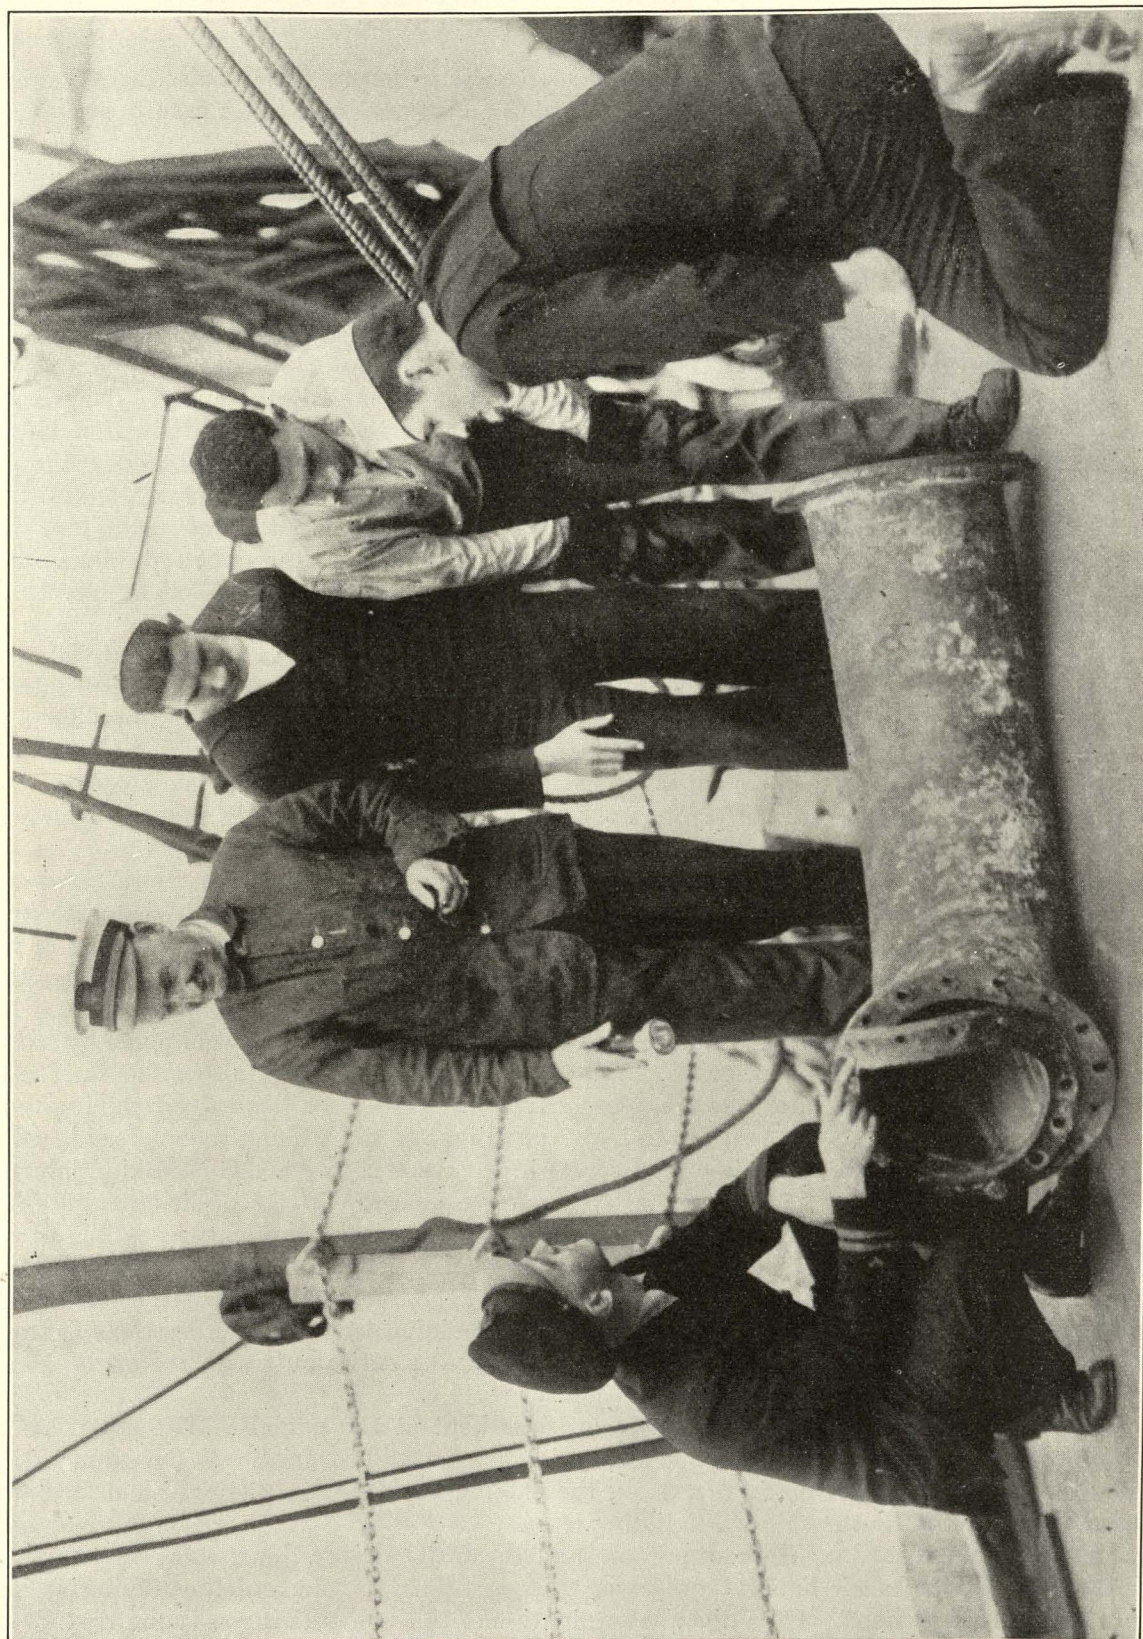
FIG. 10.—SECTION OF 12-INCH AIR SUPPLY LINE TO MOTOR ROOM, REMOVED BY DIVERS

Early in the spring operations, on May 11, 1926, work was started to seal off the ventilation main leading to the C. O. C., the engine room, and the motor room. The motor room was first attempted, as the ventilation main leading to this compartment could be most readily reached of the three compartments. The deck of the submarine just forward of the motor room was removed, and the deck beams covering the ventilation main were then burned clear by Chief Torpedoman Kelley. Work was then started on unbolting both flanges of a section of this 12-inch main for the purpose of blanking it off on the motor room side. After some days all the bolts were removed from the after flange, but several of the bolts in the forward flange were practically inaccessible due to their location close alongside the engine air induction valve. After several attempts by divers to get at these bolts, it was determined, after an inspection by the salvage officer, that there was no need to unbolt both flanges. Consequently, a wire line was tied around the pipe near the unbolted flange and on heaving from the *Falcon* the pipe was torn out of the ship, the forward flange breaking off the pipe while the unbolted flange came clear. The joint left in the ship was then scraped clean by divers and a new blank flange, which was immediately made, was securely bolted on. (See figs. 10, 11, and 12.)

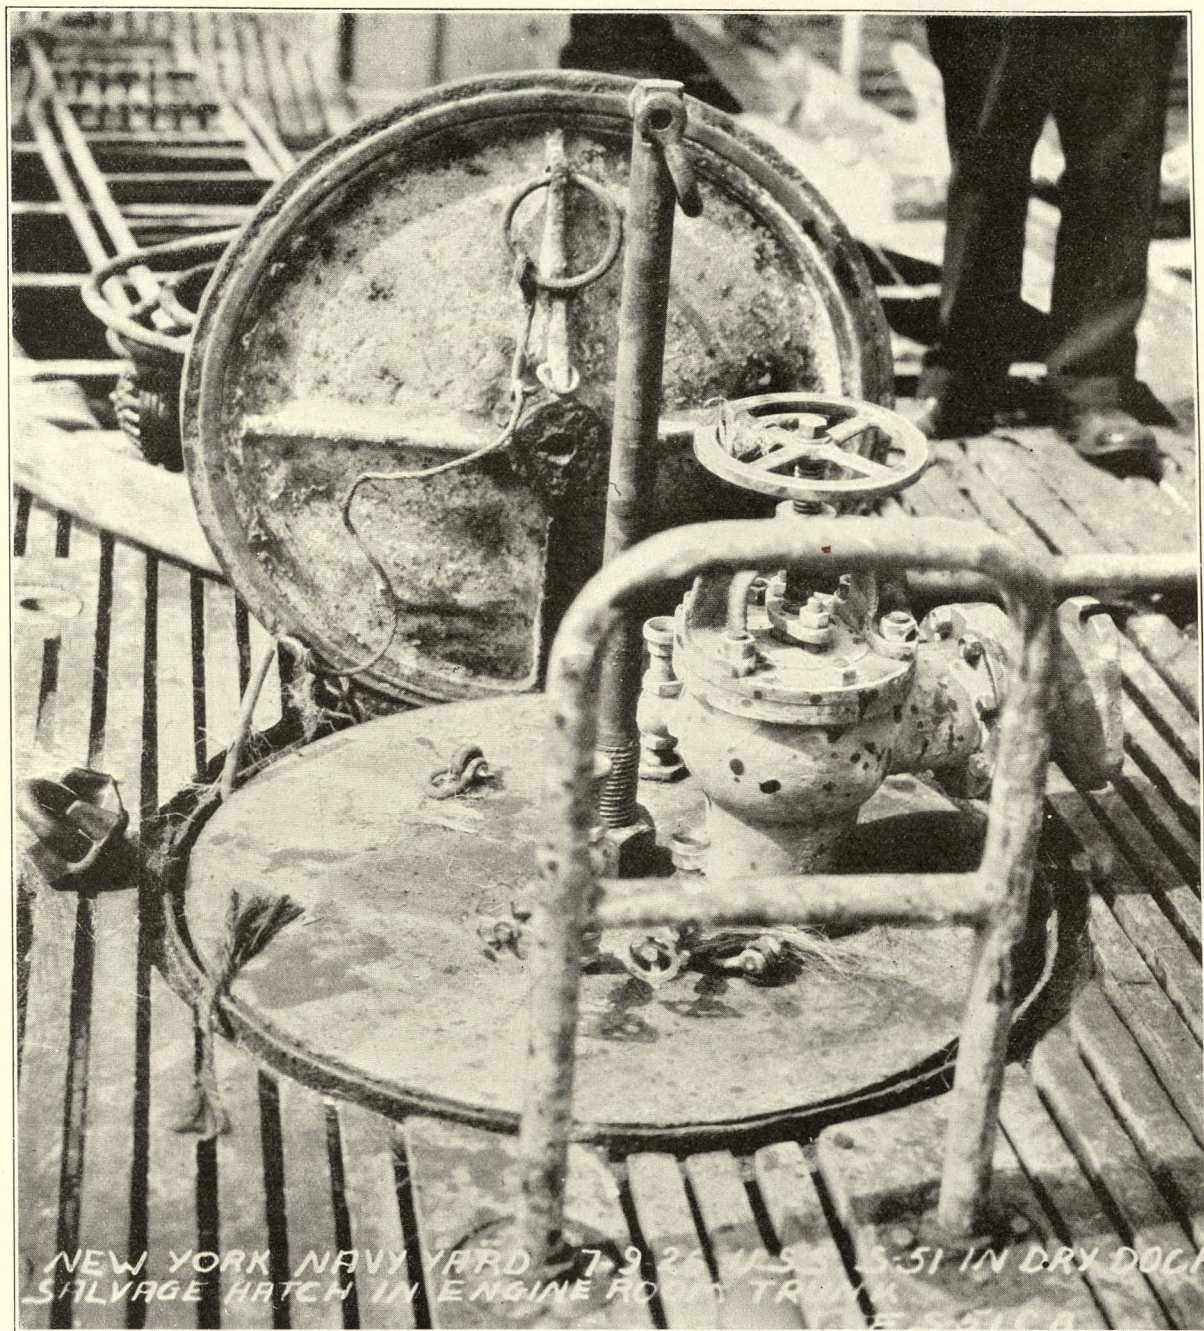
FIG. 14.—ENGINE ROOM SALVAGE HATCH IN POSITION. (NOTE THREE AIR CONNECTIONS)

To handle this hatch, the *Vestal* built a small davit similar in size to the torpedo crane used on submarines; this was sent down and set up on the submarine by the divers to plumb the engine room hatch. The engine room hatch differed from the gun access and conning tower hatches in being larger and in having a trunk 30 inches long from engine room to deck. This placed the strong back for the engine room hatch much farther below the cover than in the cases of the covers fitted over the conning tower and the gun access hatches.

Divers Smith and Carr were rehearsed on the installation of the hatch on the *S-50* under conditions approximating those on the *S-51*. They then descended to the *S-51* and the hatch assembly was lowered down to the *S-51*'s deck where the divers hooked it with a chain fall from the davit and attempted to install it. The attempt failed due to inability to get the strong back centered at the bottom of the deep trunk, a difficulty caused by the heel of the *S-51* to port which resulted in the heavy hatch and its strong back sliding off repeatedly to the low side. After a struggle lasting 3 hours and 20 minutes, the two divers, against their will, were told to cease and come up. On this, the longest dive ever made on the *S-51* job, the divers were given a decompression of nine hours and, while very weak afterwards, showed no signs of the "bends."

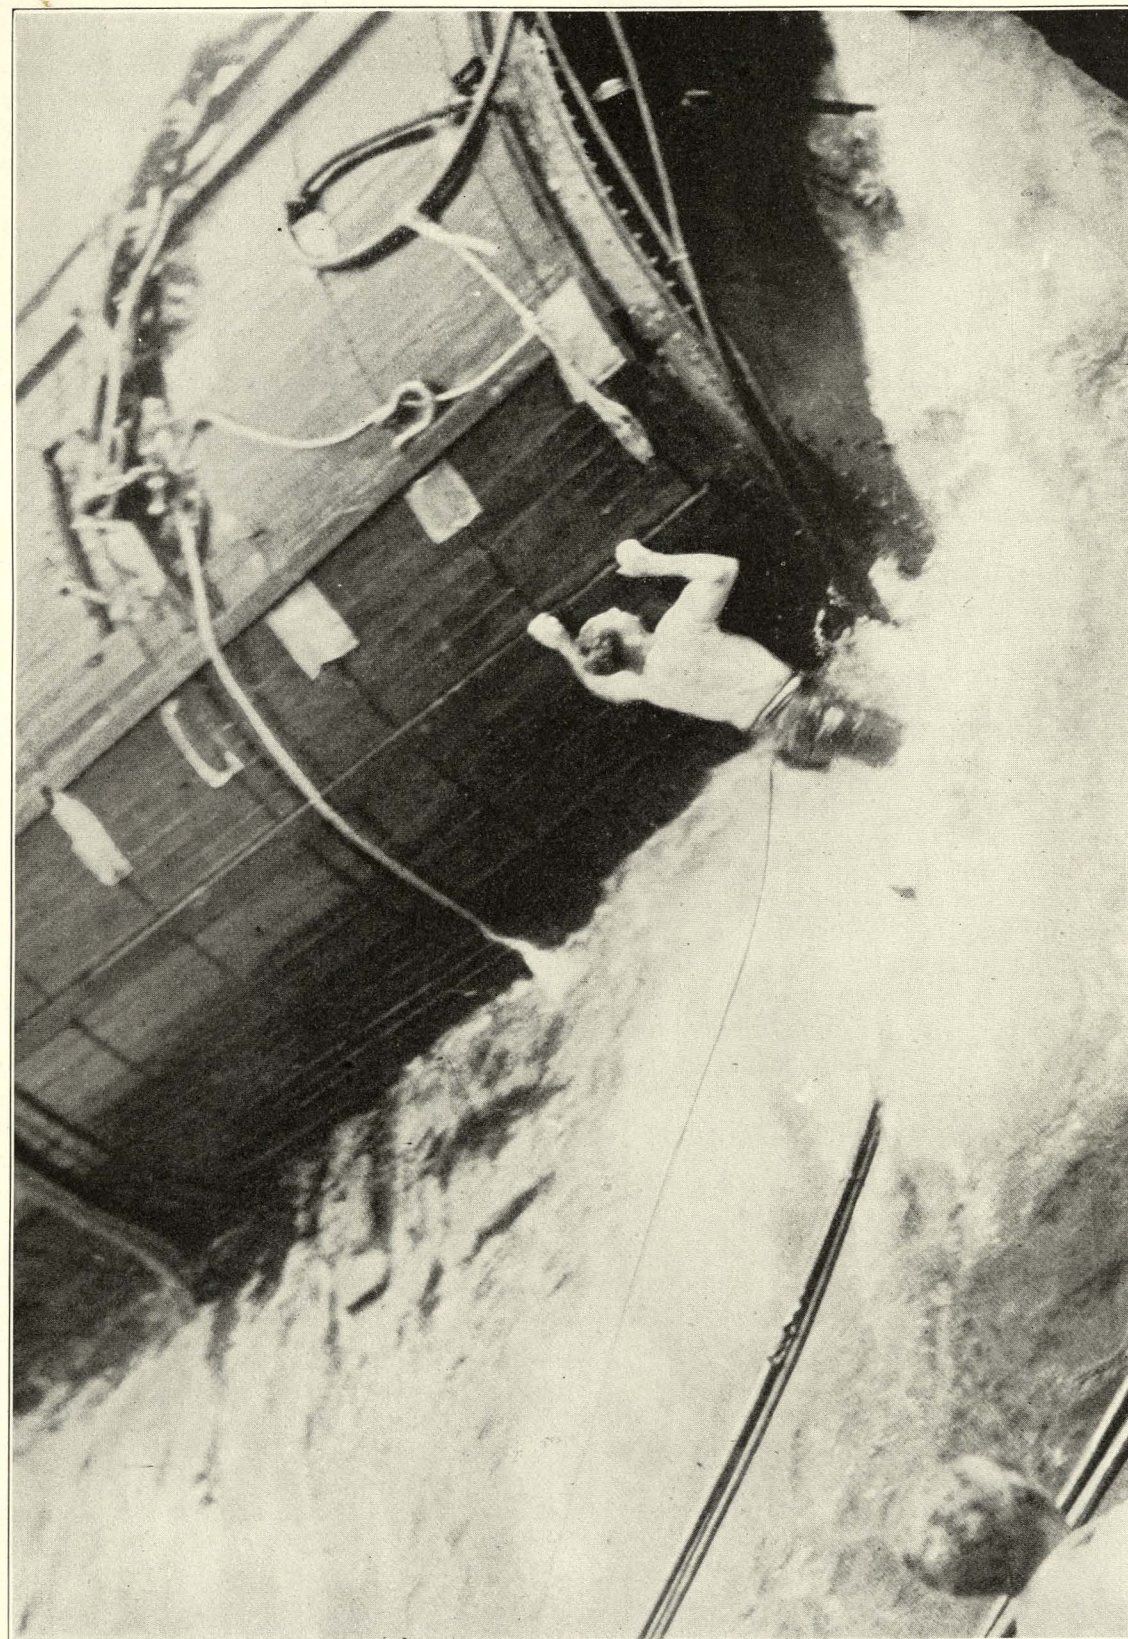
FIG. 17.—WICKWIRE BOARDING BOW PONTOONS, JUNE 22, 1926

The order to open the valves and sink the pontoons was given to Boatswain Hawes and the surfboat crew (see figs. 17 and 18); three men, Badders, Wickwire, and Weaver, volunteered to carry it out. One at a time they boarded the pontoons and fought the sea; pounded into a state of collapse they were successively hauled back to the surfboat each with the valves on his pontoon open; with his men all gone Boatswain Hawes himself leaped aboard the last pontoon and swung open its valves.

The *S-51* was found with a strong starboard list, about 20°, and with the bow clear of the bottom back to frame 40; the stern was on the bottom. There was no evidence either forward or aft of damage to the *S-51* due to the events of the previous day, except some dents in the bow buoyancy tanks where the pontoons had rubbed. The midship pair of pontoons

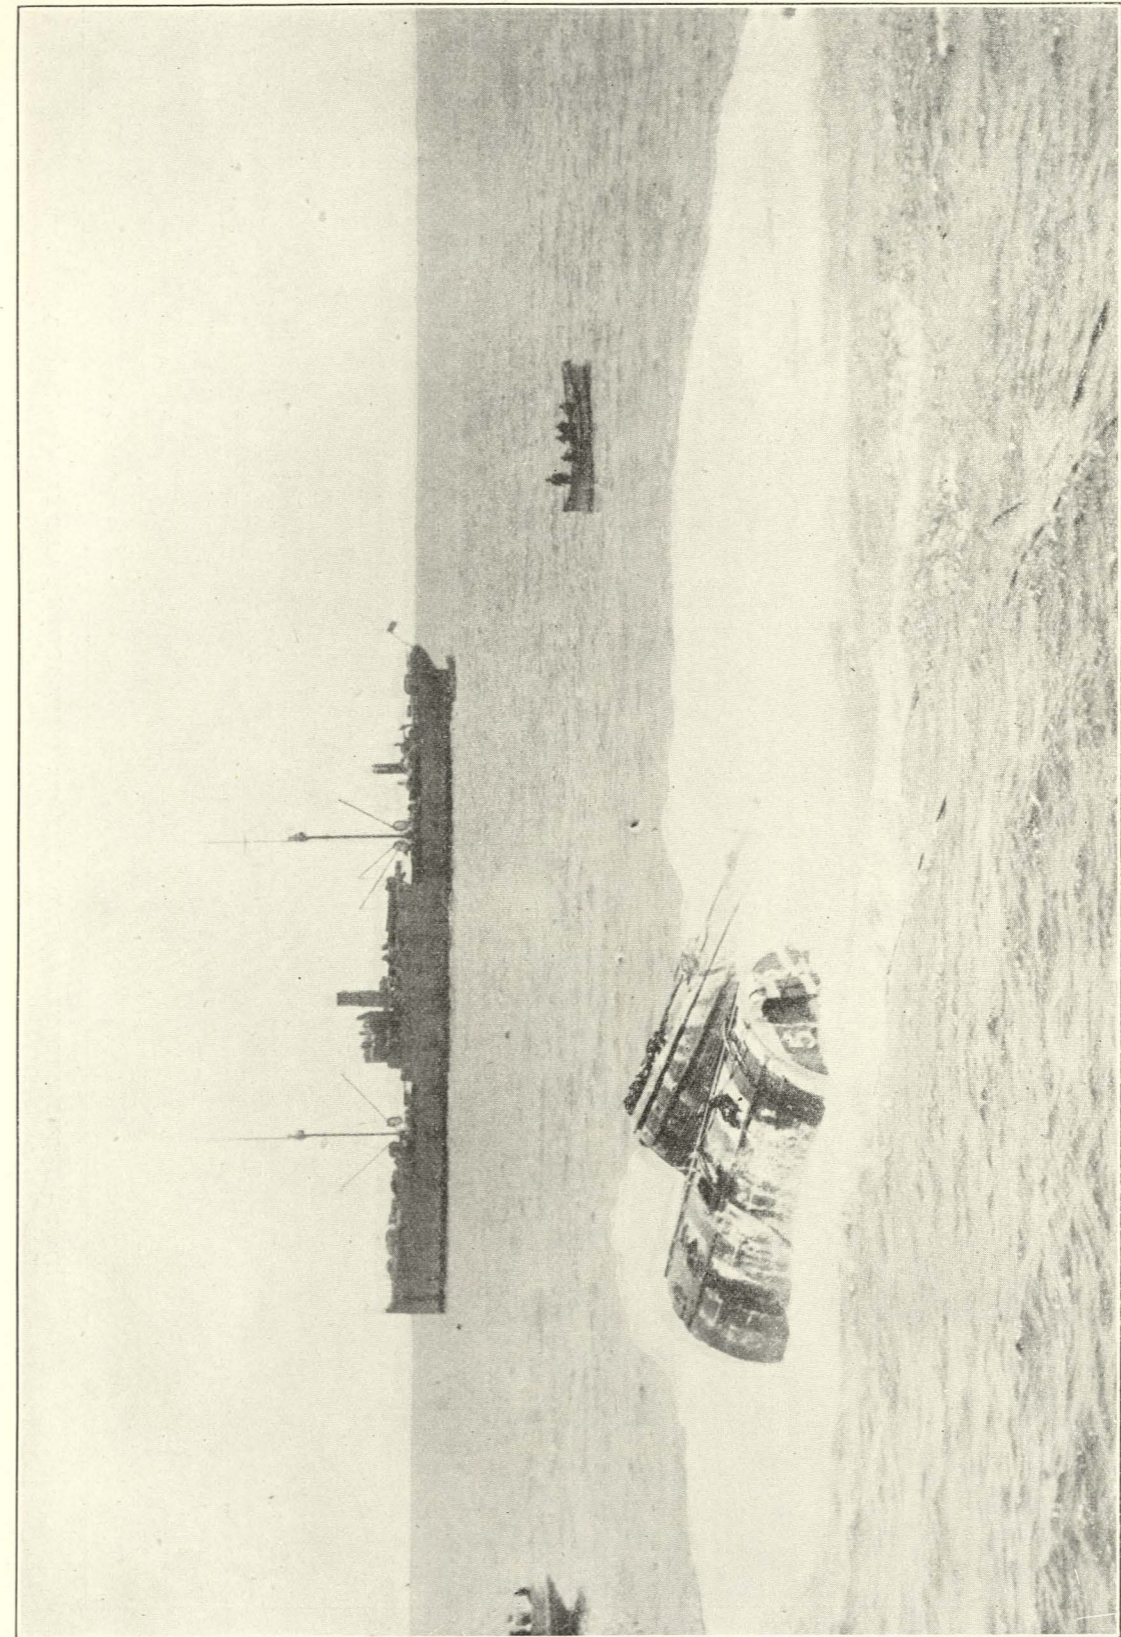
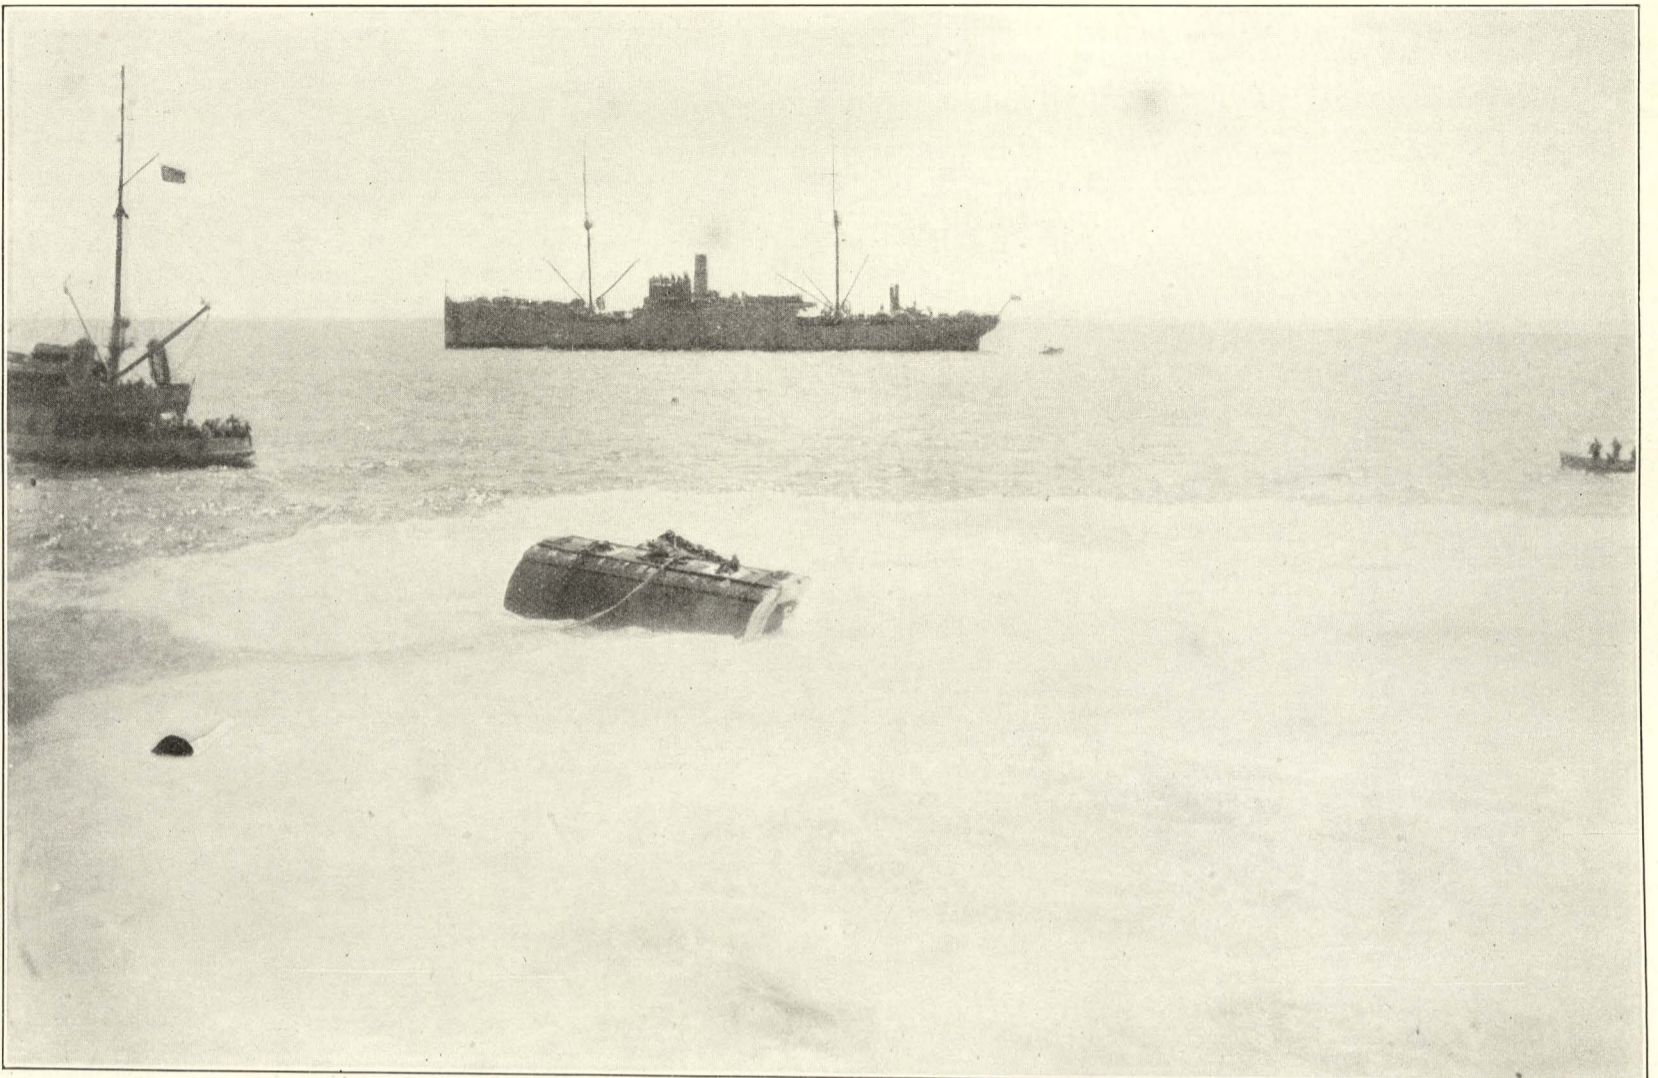
At 2.06 p. m., after blowing the stern pontoons for only 11 minutes, a large mass of bubbles appeared at the stern; shortly after the stern pontoons broke through the surface, riding easily with over half their volume exposed. They were probably not over half buoyant when the stern started to rise. (See figs. 20 and 21.)

FIG. 20.—STERN PONTOONS BREAKING SURFACE. (NOTE ACTION OF AIR FROM PONTOONS)

FIG. 21.—STERN PONTOONS BREAKING SURFACE. (NOTE ACTION OF AIR FROM PONTOONS)

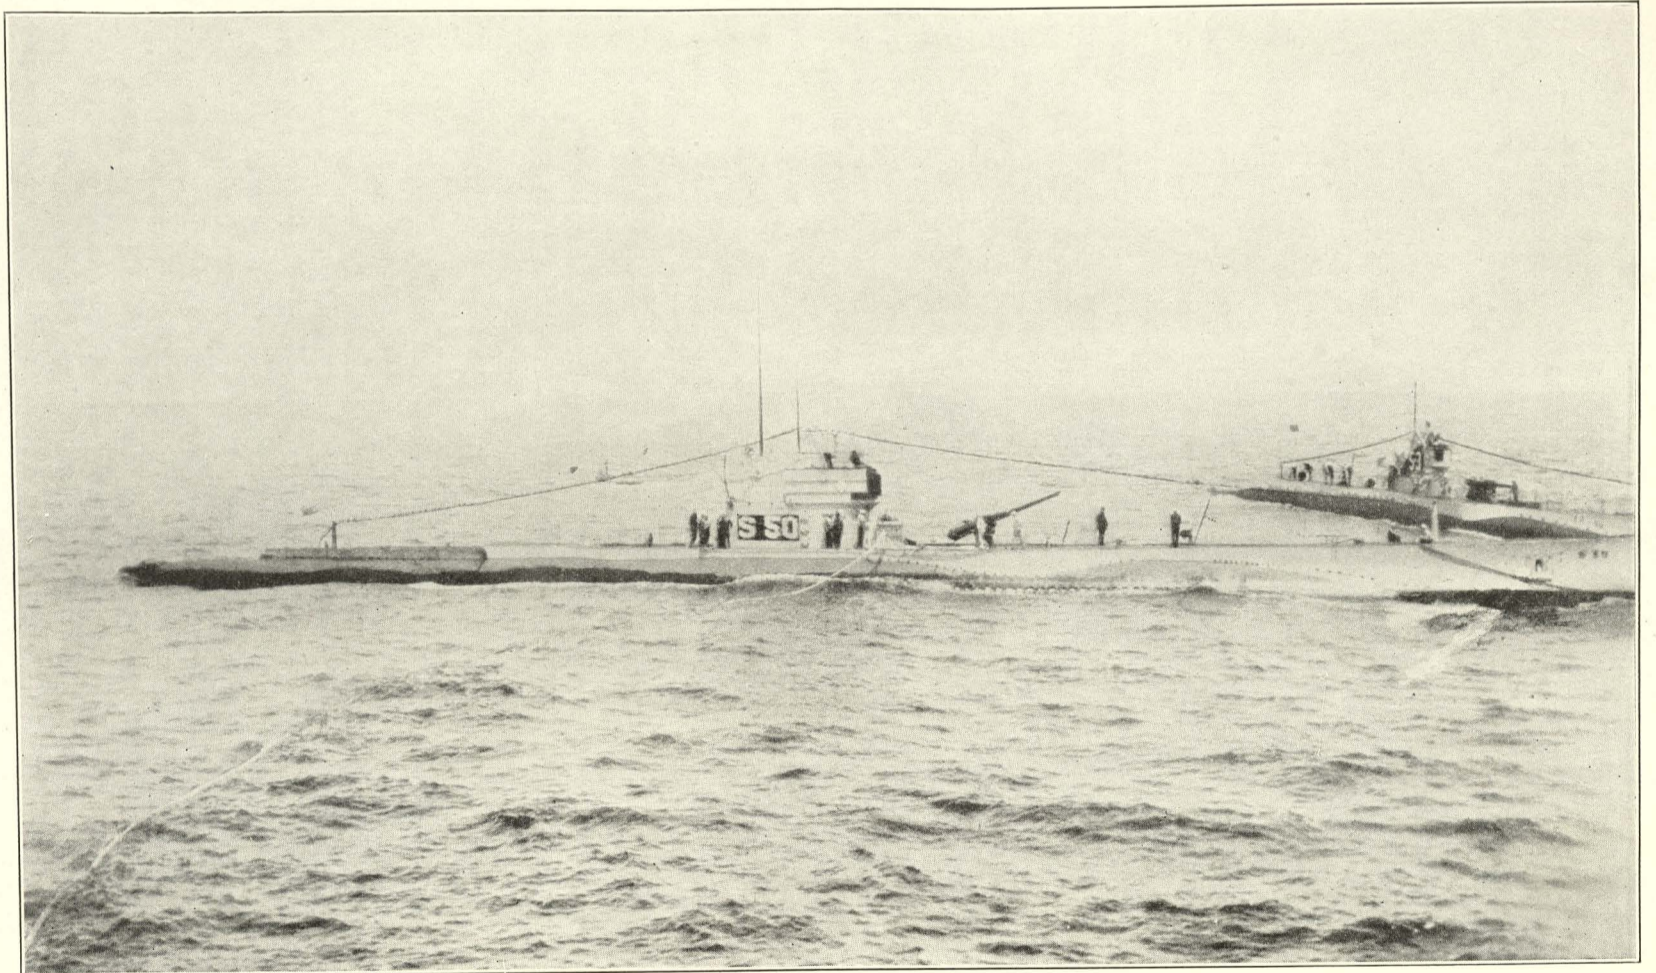
At this time the *S-50* reported all the air in her high-pressure banks used up; she started up both her compressors, while the *S-3* maneuvered to come in alongside the *S-50* and run a high-pressure air line to her to help out. (See fig. 22.)

FIG. 22.—"S-50" SUPPLYING AIR TO "FALCON." "S-3" MANEUVERING ALONGSIDE "S-50." (NOTE 2½-INCH FIRE HOSE WHICH CARRIED AIR TO "FALCON")

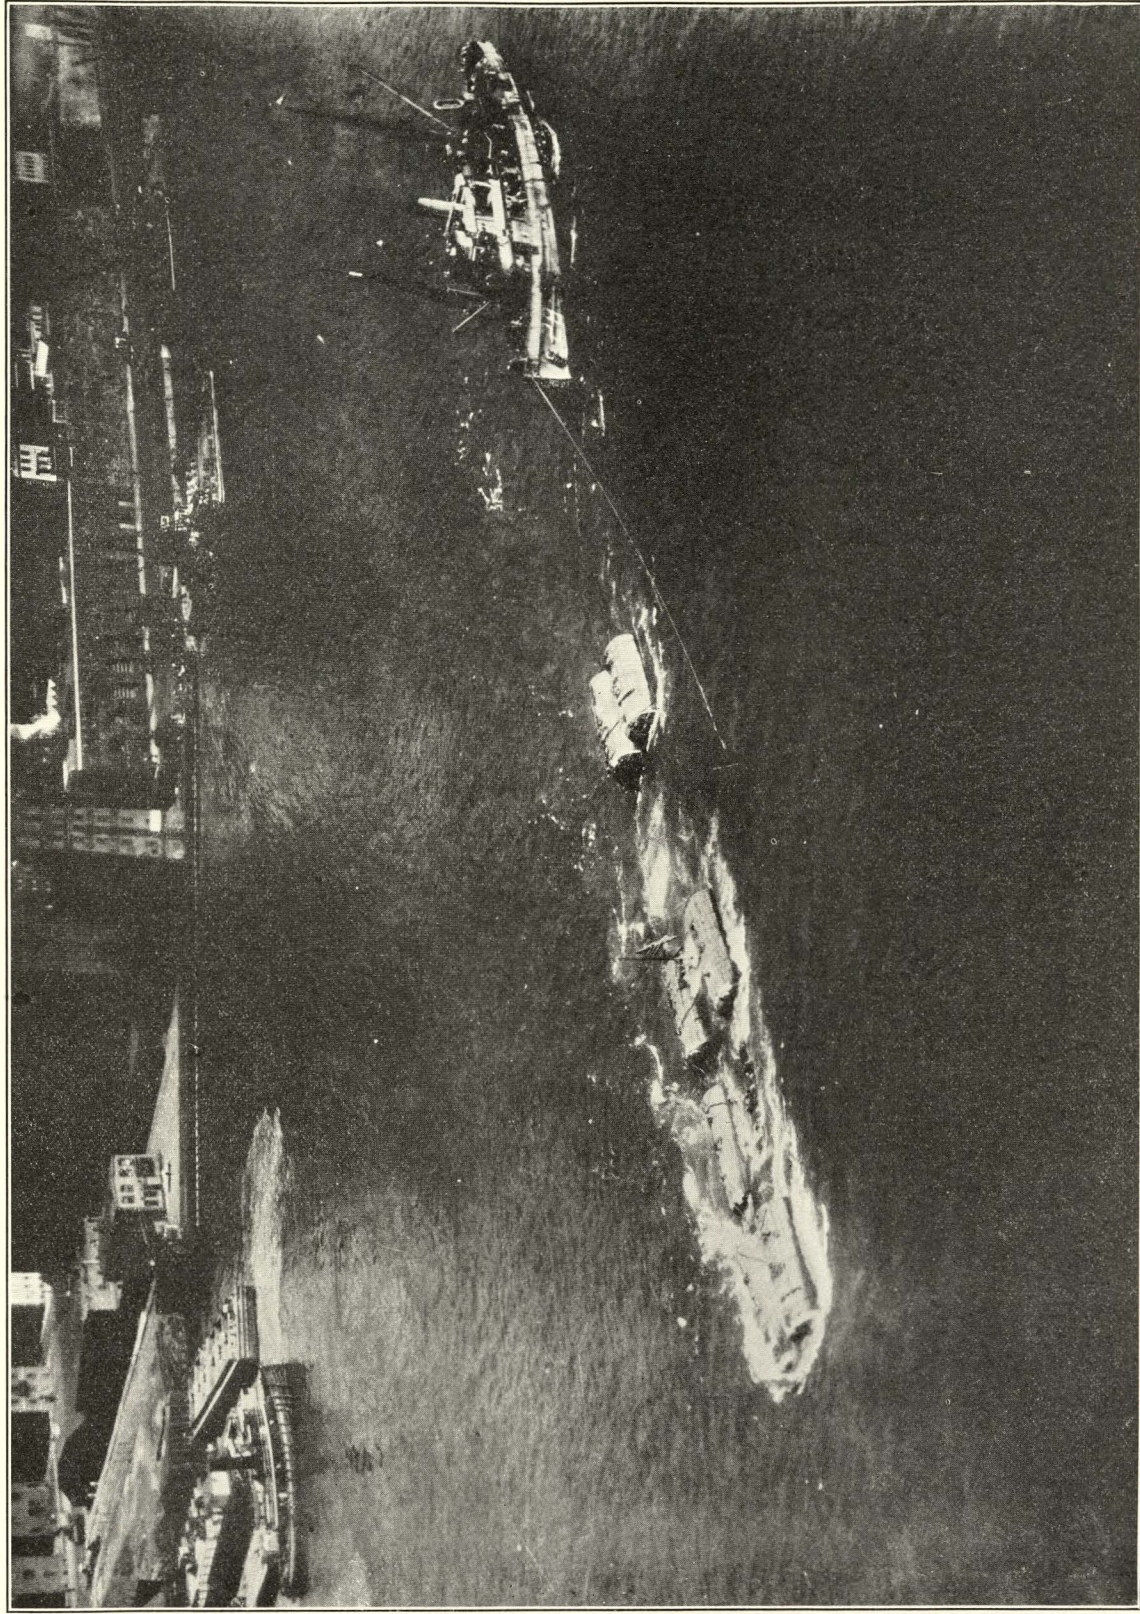
The position of the pontoons during the tow is shown by Figure 26 and Plate 6. The stern pair of pontoons was farthest exposed, as was expected. The No. 1 and No. 3 pairs of pontoons were floating at about the water line designed, with slight cockbilling. The port pontoon of the No. 2 pair was just awash, while its mate was floating about one-fourth exposed. This relation was probably caused by the lashing wires for these two pontoons binding across the deck of the submarine and preventing the chains from rendering enough to equalize the submersion. All pontoons were seen to be exactly in the fore-and-aft alignment to which they had been set on the bottom.

As a further safeguard, the order was given before getting under way to close all flood valves on the pontoons. A check made after getting under way showed that the flood valve on the after end of No. 3 starboard pontoon turned freely but would not close; also, that as No. 2 port pontoon was awash the boat crew had not closed the valves on it.

This last condition was felt to be dangerous. If anything carried away the two air hoses to this pontoon, the pontoon would be entirely free to flood (which its awash condition would expedite) and such sinking would cause the loss of this pair of pontoons and possible disaster in the open sea.

FIG. 26.—ARRANGEMENT OF PONTOONS

When the condition of No. 2 port pontoon was reported, the tow was halted for about an hour and the surfboat sent out to close the flood valves. The seas were steadily breaking over this awash pontoon, which made work on it dangerous. The boat could not come alongside, but one by one Wickwire, Hawes, Lieutenant Kelly, and Schissel swam from the surfboat to the pontoon and finally succeeded in shutting off the flood valves; as an additional precaution, the blow valves were also closed.
