# Report on Salvage Operations Submarine S-51

REPORT ON SALVAGE OPERATIONS  
SUBMARINE S-51

EDWARD ELLSBERG  
LIEUTENANT COMMANDER, CONSTRUCTION CORPS  
UNITED STATES NAVY  
SALVAGE OFFICER

UNITED STATES  
GOVERNMENT PRINTING OFFICE  
WASHINGTON  
1927

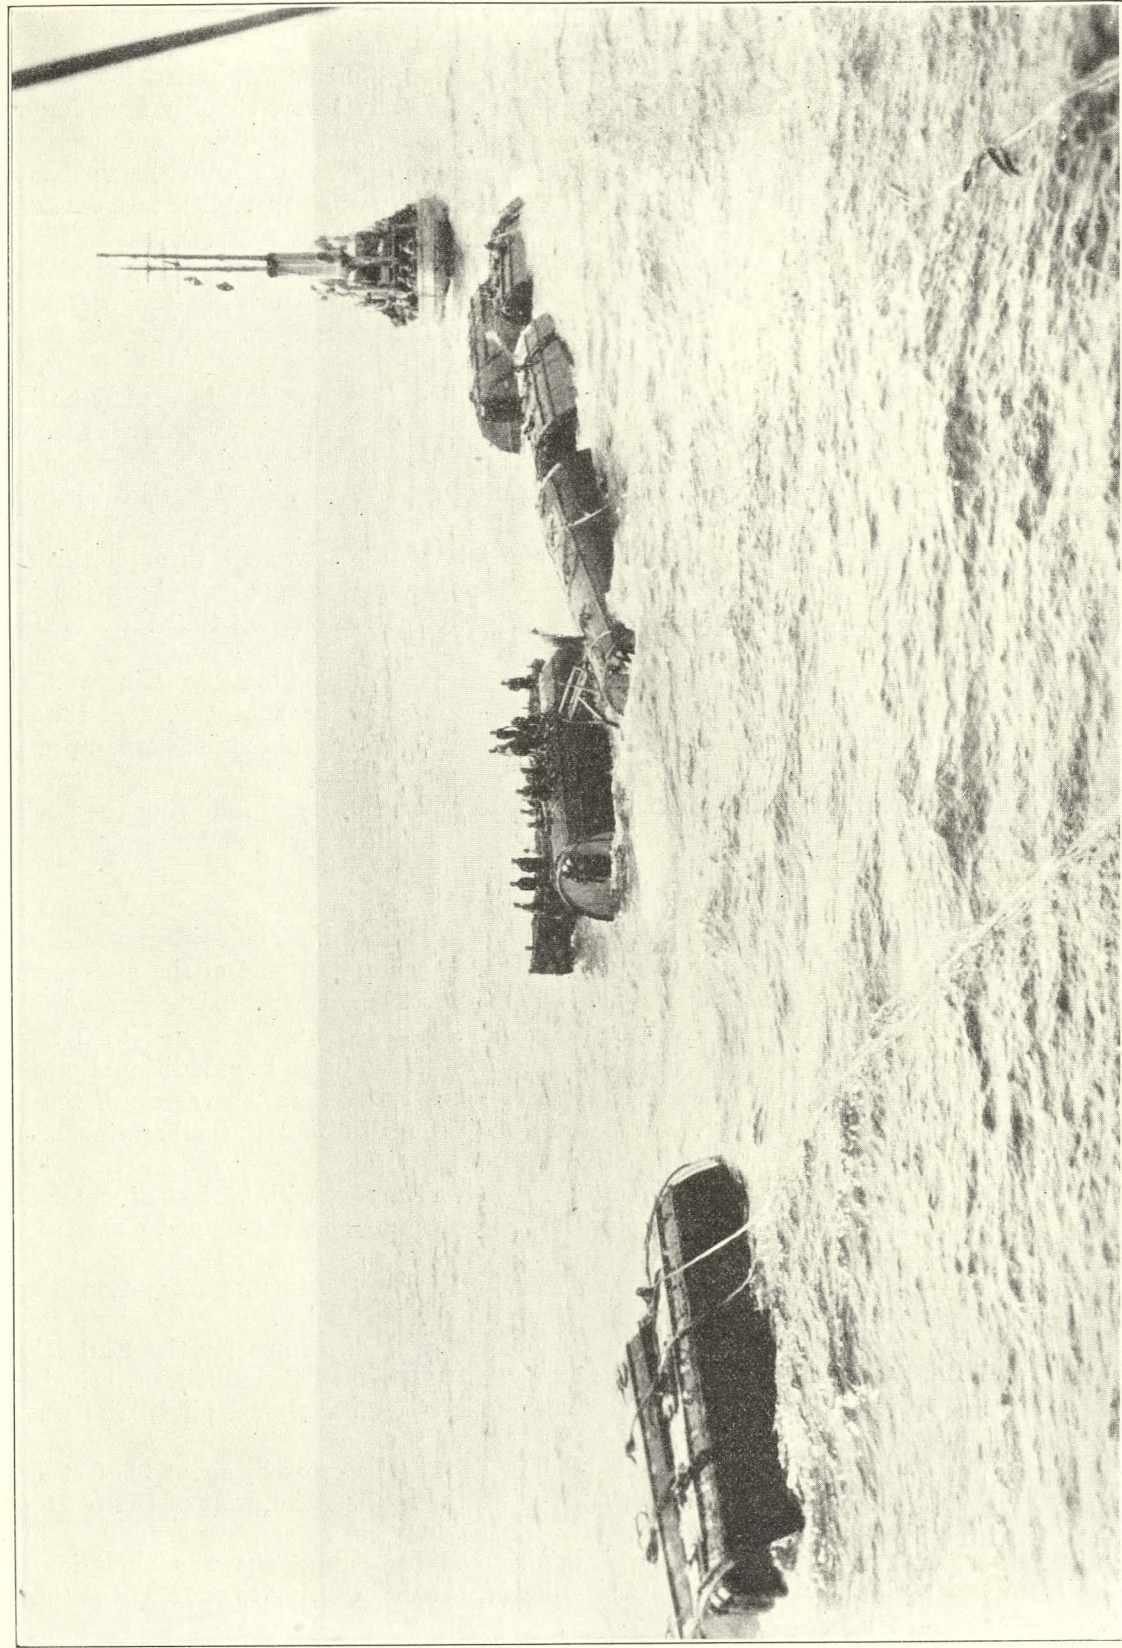
The only part of the *S-51* which was clear of the water was her signal bridge over the conning tower; her No. 3 periscope which showed undamaged about 5 feet above the surface; and the stub of her mast which was exposed the same amount (the remainder of the mast had been removed as an obstruction during salvage work). The top of the periscope shears could be plainly seen about 6 inches below the surface, but nothing else was visible. From the periscope it was observed that the *S-51*, as slung between the pontoons, was floating with a steady list to starboard of about 10°. (See fig. 27.)

FIG. 27.—"S-51" AFLOAT ON PONTOONS. (NOTE TOP OF PERISCOPE SHEARS AND ANGLE OF HEEL)

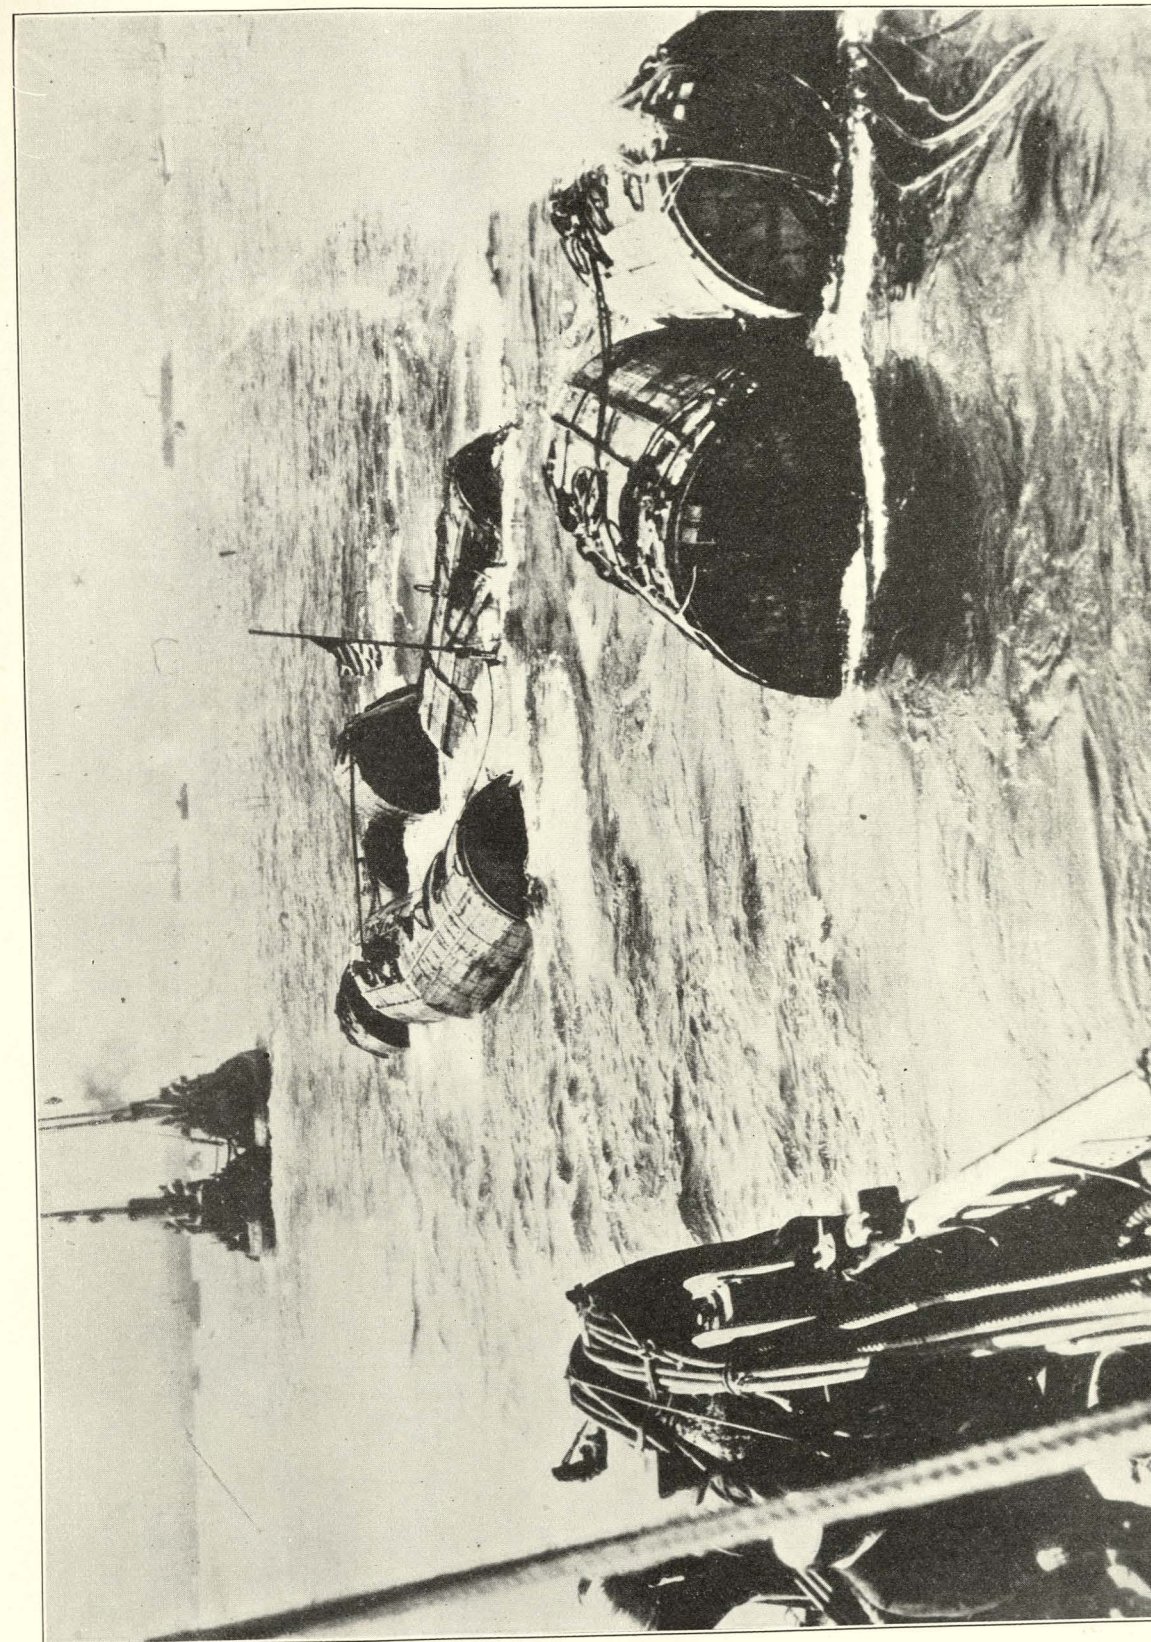
The tow now passed down the East River on the top of the morning high tide, passed to the westward of Blackwells Island, and was practically on its last mile with the entrance to the navy yard in sight, when it was observed that instead of following the *Vestal* the *Iuka* and the *Sagamore* were swinging off strongly to port, taking the *S-51* and the *Falcon* with them. Before the meaning or the reason for this unexpected maneuver could be learned there came a sudden bobbing of the pontoons at the bow of the *S-51*, the No. 2 pair, which was nearly awash, floated up completely light, and the *Falcon* found herself rapidly closing on the stern of the submarine. (Fig. 29.)

The cause of this occurrence was not at first grasped by the salvage officers. Knowing that a deep, broad channel existed for the pilot to follow, it did not occur to them that the *S-51* had grounded. Wild as the idea seemed, and with no reason for believing it probable, it was thought at first that the *S-51* had broken in two forward, thus releasing the No. 2 pair of pontoons and stopping the tow. But a hasty examination from the surfboat showed the submarine intact; in spite of having swung nearly 180° since grounding, the three pairs of pontoons still left lined up in a perfectly straight line which was impossible with the submarine in two pieces.

The next surmise was that *S-51* had hit a submerged wreck; this was being checked by soundings, when a fix obtained on the *Falcon*'s bridge and plotted on the chart disclosed that the pilot had left the main channel to try to pass through a narrow side channel between two reefs, had misjudged his distances and the tide, and had run the *S-51* aground on Man-of-War Rock at practically the top of the high tide. The bow of the *S-51* was found to be in a little over 24 feet of water.

A hasty estimate was made of the situation. Up to the moment of grounding, the No. 2 pair of pontoons showed by their immersion that they were exerting a net lift of about 120 tons, which was now lost. A check on the previous reserve buoyancy of the No. 1 pair and the No. 3

FIG. 29.—AT THE INSTANT OF GROUNDING ON MAN-OF-WAR ROCK. (NOTE NO. 2 PAIR OF PONTOONS RISING AND DRIFTING TO STARBOARD)

pair showed a reserve in those two pairs of slightly more than this. If this reserve could be brought into action it would overbalance the lost buoyancy and would maintain at least as high a forward moment, as the No. 2 pair had been located exactly between the No. 1 and No. 3 pairs. (See fig. 30.)

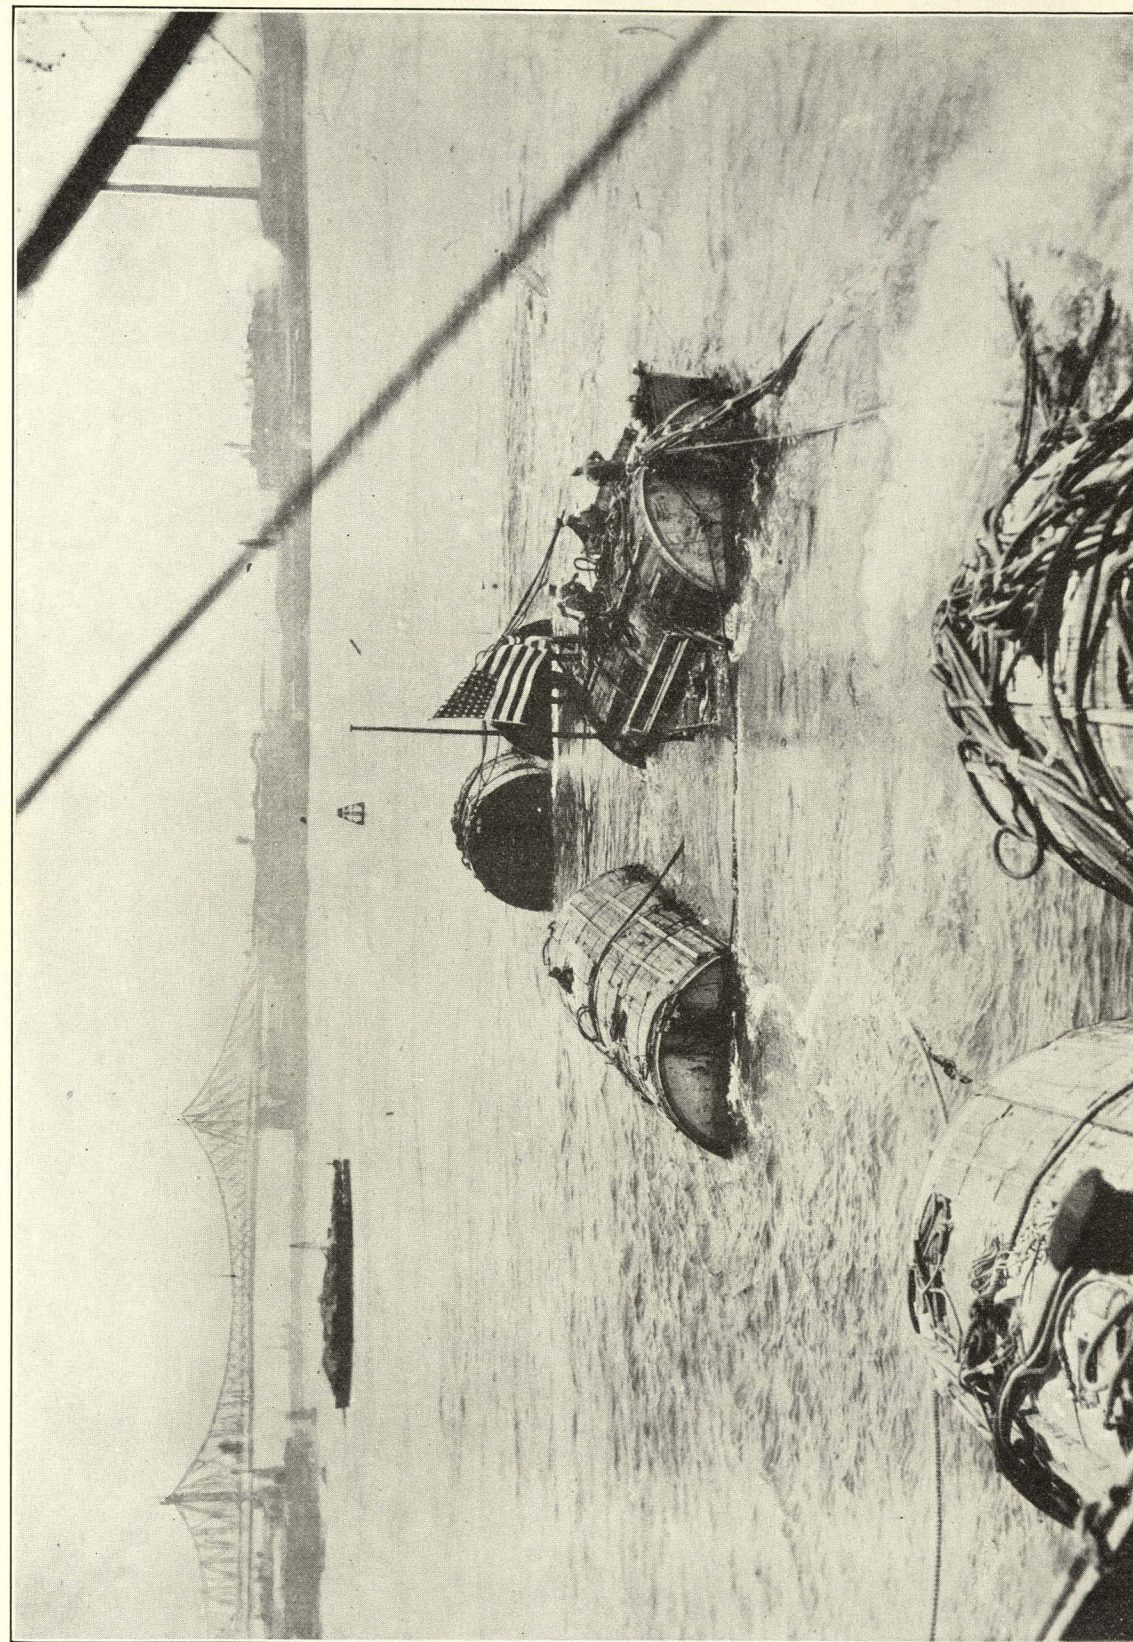
FIG. 30.—"S-51" ON MAN-OF-WAR ROCK. CLEARING HOSES IN PREPARATION OF LOWERING PONTOONS

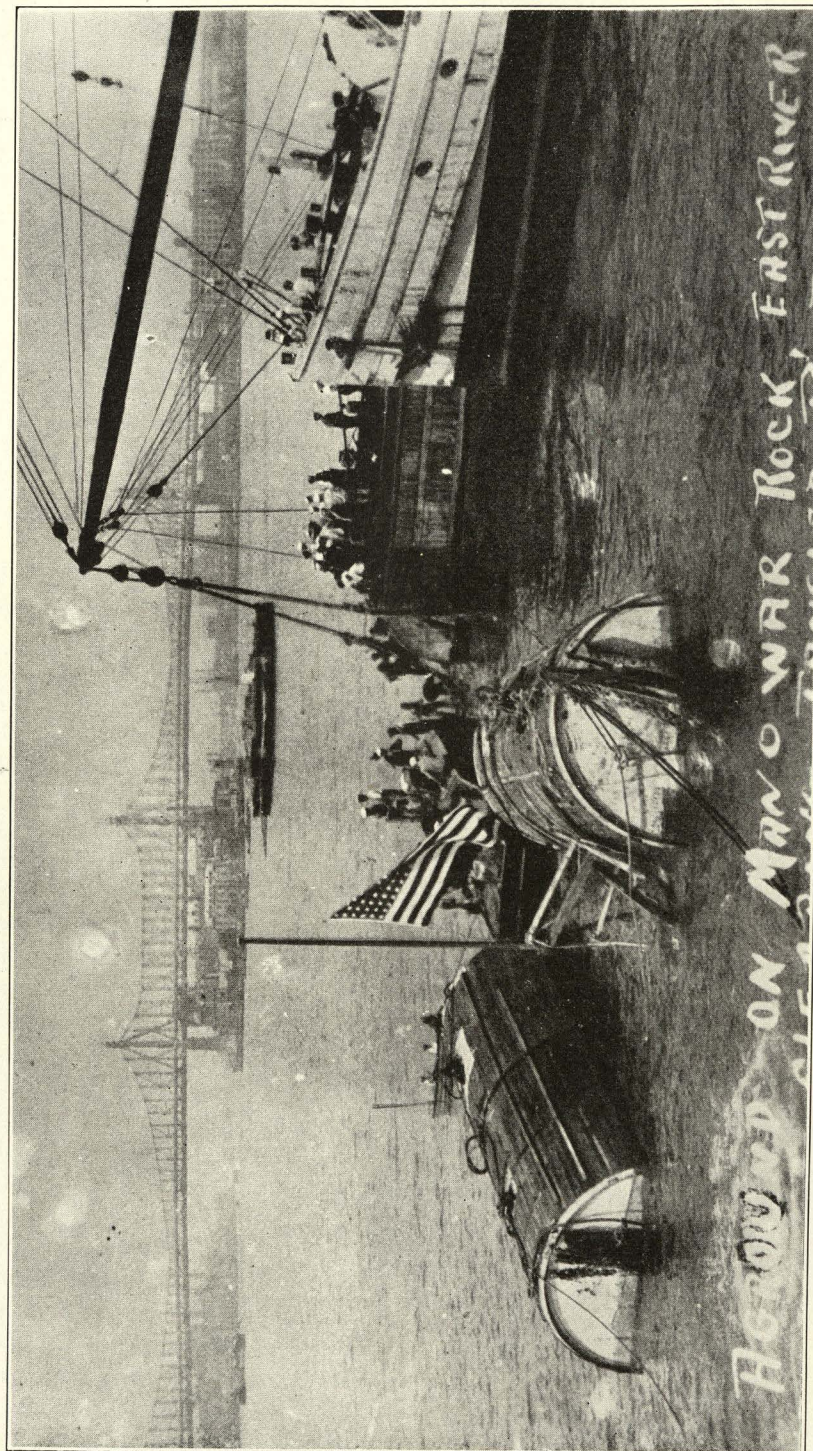
FIG. 31.—TWENTY-FIVE-TON DERRICK TAKING MAXIMUM STRAIN ON CHAINS OF PORT PONTOON. PONTOON BELOW SURFACE AND DIVING BOAT IN POSITION FOR INSPECTION OF BOTTOM

Two divers now went down for an examination. They found that from about frame 50 aft, the *S-51* was entirely clear of the reef; that she was resting on a shelf under her keel from this point for some distance forward, and that on her port side she was resting against a huge boulder about 8 feet higher than the keel, which was apparently what was preventing a complete swing upstream. The *S-51* was lying well over on her starboard side, with her bilge keel on the rocks.

By slacking away the boom, it was able nearly to plumb the port No. 1 pontoon. A pair of wire slings, suspended from the boom, were shackled to the ends of the chains showing through the port pontoon hawse pipes. The derrick then took its maximum strain, the flood valves on the port pontoon were opened, and the air was vented from the pontoon to sink it. Very shortly the toggle bars on the hawse pipes came slack in the chains and were withdrawn. The pontoon was flooded down until it was awash, when the studs were burned out of the links in the chain just above the hawse pipes, the toggle bars were inserted in the new locations and the locking pins put back. A slight amount of air was blown into the pontoon until it came up hard against the toggle bars, when the derrick slacked away and cast loose the slings which were immediately secured to the chains on the starboard No. 1 pontoon. (See fig. 31.)

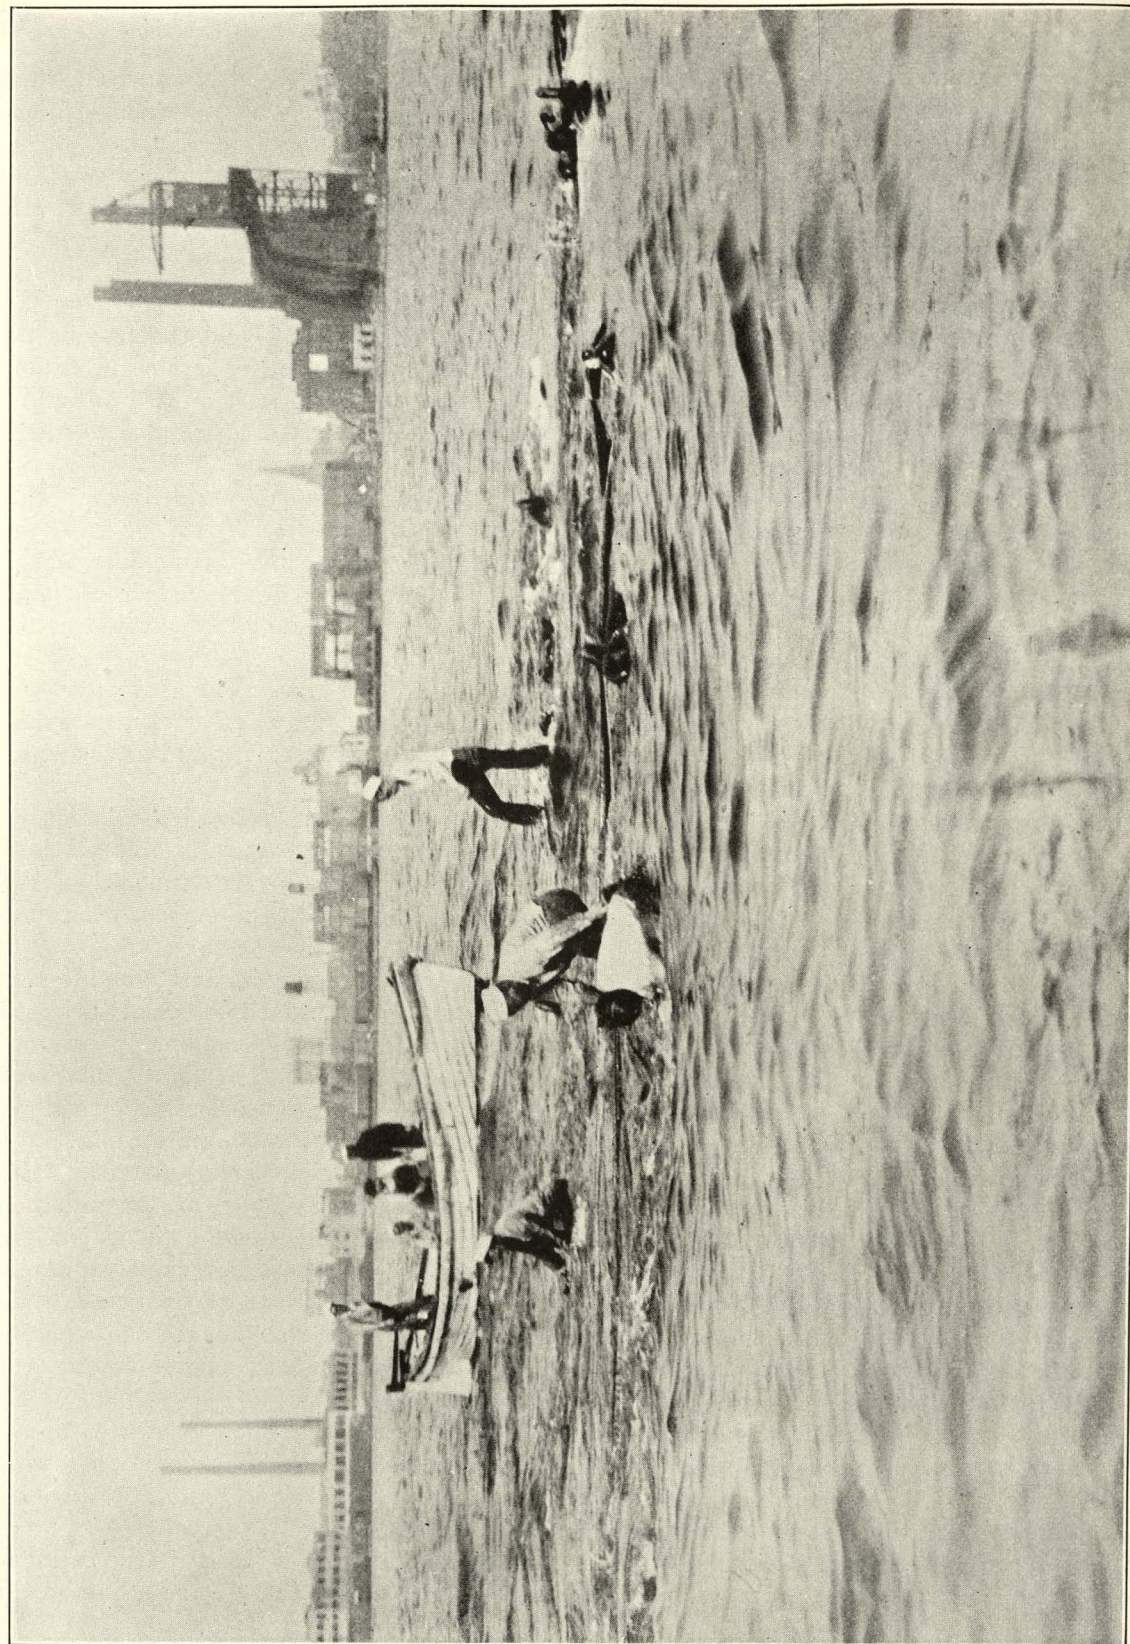
The resecuring of the starboard No. 3 pontoon was finished as darkness came on, and the derrick was taken away. The bow pair of pontoons had for some time completely disappeared below the rising tide (fig. 32); the middle pair of pontoons was also completely covered as the tide reached its maximum.

FIG. 32.—BOW PONTOONS BELOW THE SURFACE AT MAN-OF-WAR ROCK. CREW OPENING VALVES

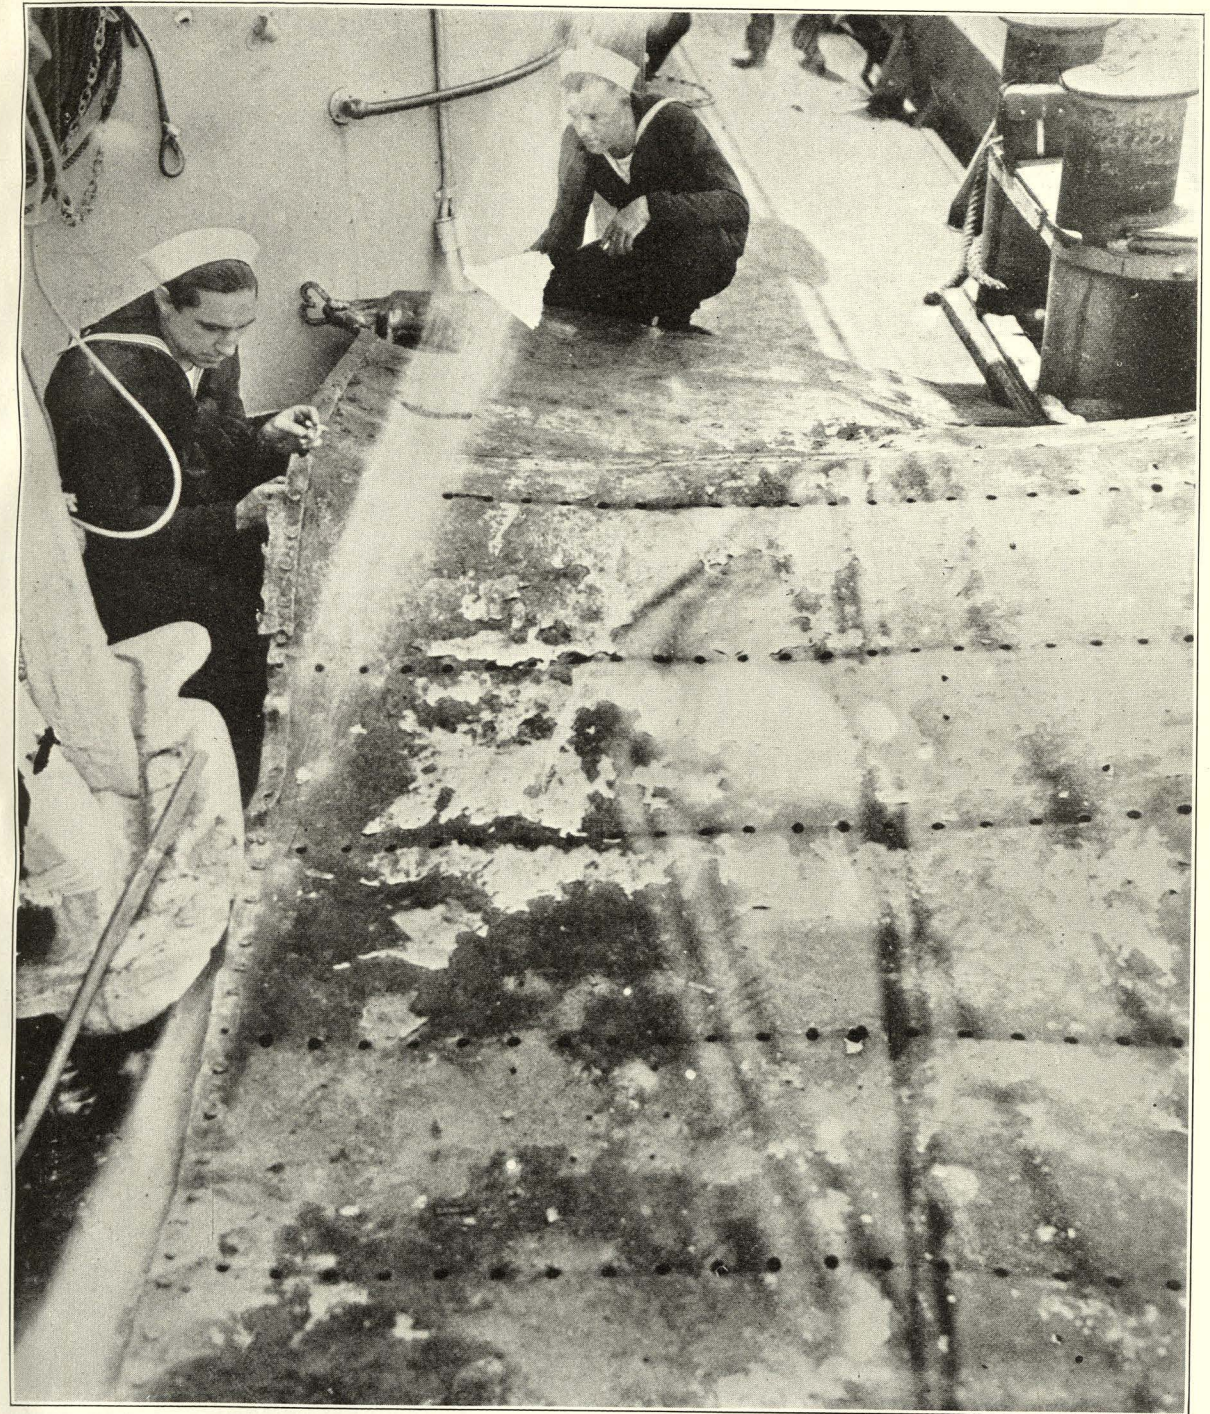
Structurally the *S-51* was found with a large gash resulting from the collision (see fig. 39) and with a deep wrinkle in the shell in way of the torpedo room bulkhead (see fig. 40). In addition the bow, which had been intact during salvage operations and during the tow, was torn away by the towline shackled into the bullnose when the *S-51* hit Man-of-War Reef. (See fig. 41.) This carried away the upper part of the stem casting and the starboard shell plate riveted to the stem; these pieces were hauled aboard the towing tug with the towline. (See fig. 42.) The bridge structure, which was very light, was originally bent slightly to port by leaning against the starboard No. 3 pontoon after the events of June 22. It was found that this contact had torn off the valve on the upper end of the voice tube from conning tower to bridge, and it was the loss of this valve which resulted in making the C. O. C. nonwater-tight on July 5. (The end of this voice tube was easily accessible, and it could have been quickly plugged had it been found necessary to seal up the C. O. C. to raise the boat.)

FIG. 42.—"S-51" BOW PLATING AND STEM CASTING ON BOARD "SAGAMORE"
